Construction Stormwater Site Inspection Case Study #1: Project Closeout and Ongoing Maintenance Issues

Construction Stormwater Site Inspection Case Study #2: Stabilization Issues and Poorly Maintained ESC BMPs

Construction Stormwater Site Inspection Case Study #3: Insufficient Erosion and Sediment Control BMPs

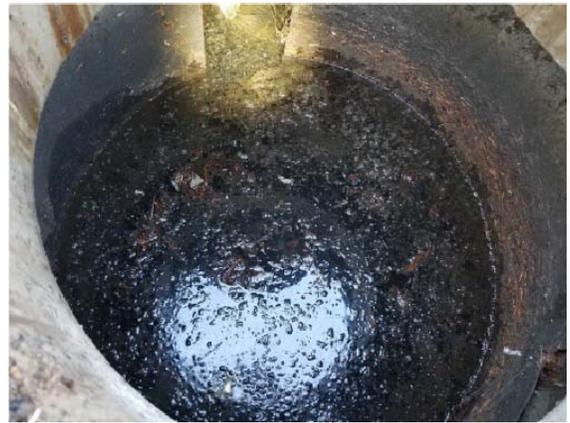
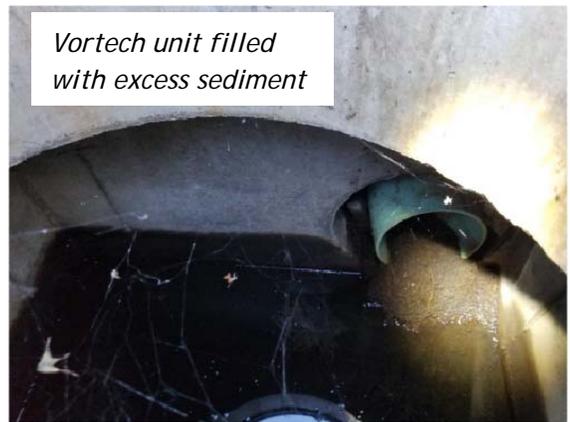
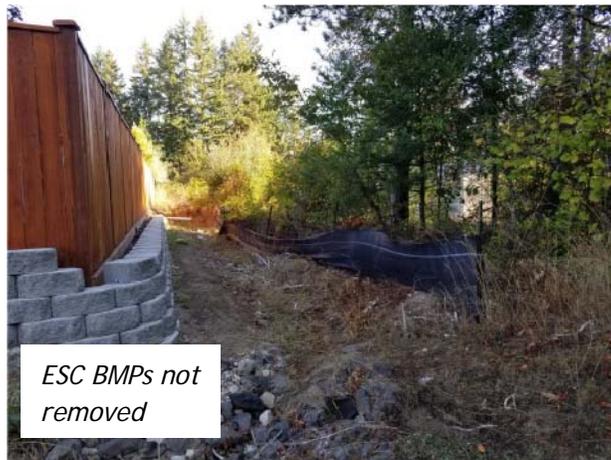
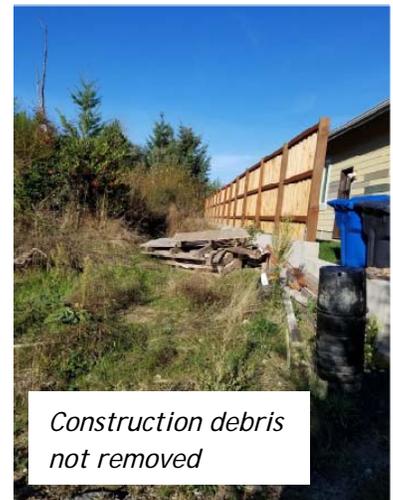
After completion of plat construction, temporary ESC BMPs were not removed and the storm tract was not maintained. Ongoing issues with storm system are present due to lack of maintenance. City ESC inspector had to remove a silt sock clogging a Vortech unit.

Not resolved. There now is an HOA trying to form. They are not happy about the condition of their new system, likely due to no final inspection and no enforced maintenance of storm system while contractor was developing plat.

Sent multiple (even certified) requests to contractor. Completed a full inspection of site and send list of deficiencies to contractor.

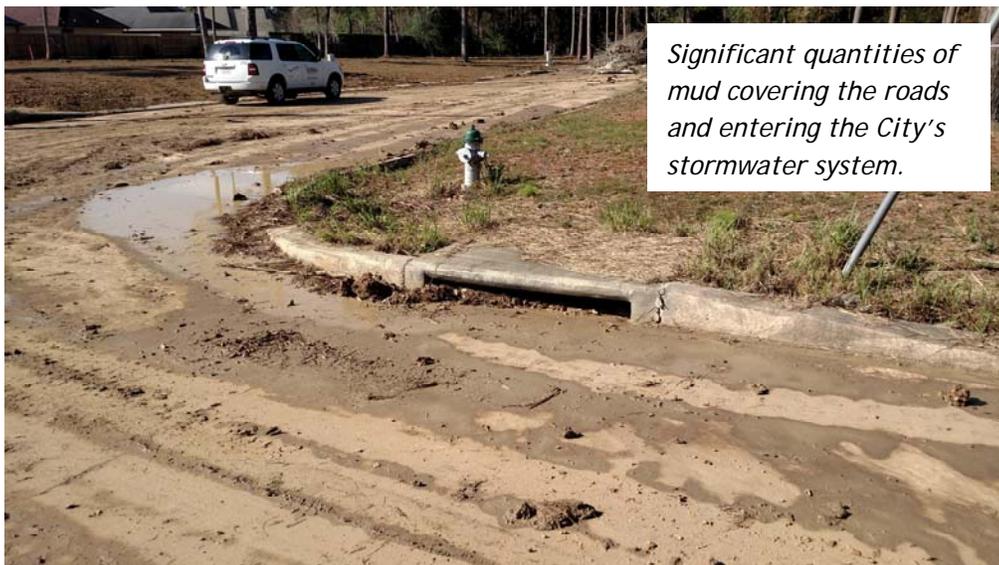
The inspector received complaints of mud and illicit discharge in the public right of way immediately following a heavy rain event. Upon preliminary inspection, it was discovered that the vegetative buffer that the contractor elected to use was no longer present and significant quantities of mud were covering the roads and entering the City's stormwater system. In addition, the contractor had continued work with equipment to relocate construction supplies onto the right of way, tracking out more heavy clay soils throughout the entire subdivision. Catch basins in the subdivision contained as much as 6 inches of heavy clay soils at the bottom.

Stop Work Orders were issued on all three projects and the contractor was ordered to immediately begin work to clean and remove the sediment on the roadway. The contractor was also required to clean out and remove sediments throughout the subdivision's stormwater lines and catch basins. It was requested that the contractor should add silt fence to the project limits.

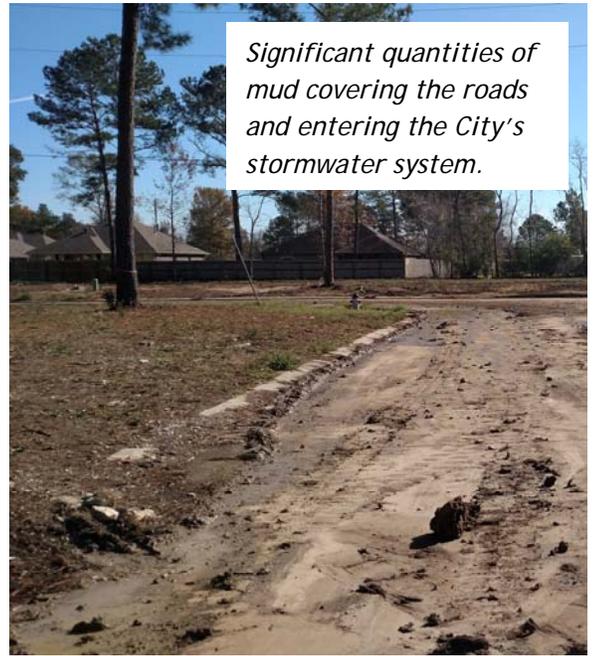
Significant quantities of mud covering the roads and entering the City's stormwater system.
