Stormwater Retrofits for Treating Highway Runoff

*Annotated Presentation given
at MuniCon on May 17, 2017.*

*By: Carly Greyell
King County
Water and Land Resources Division*

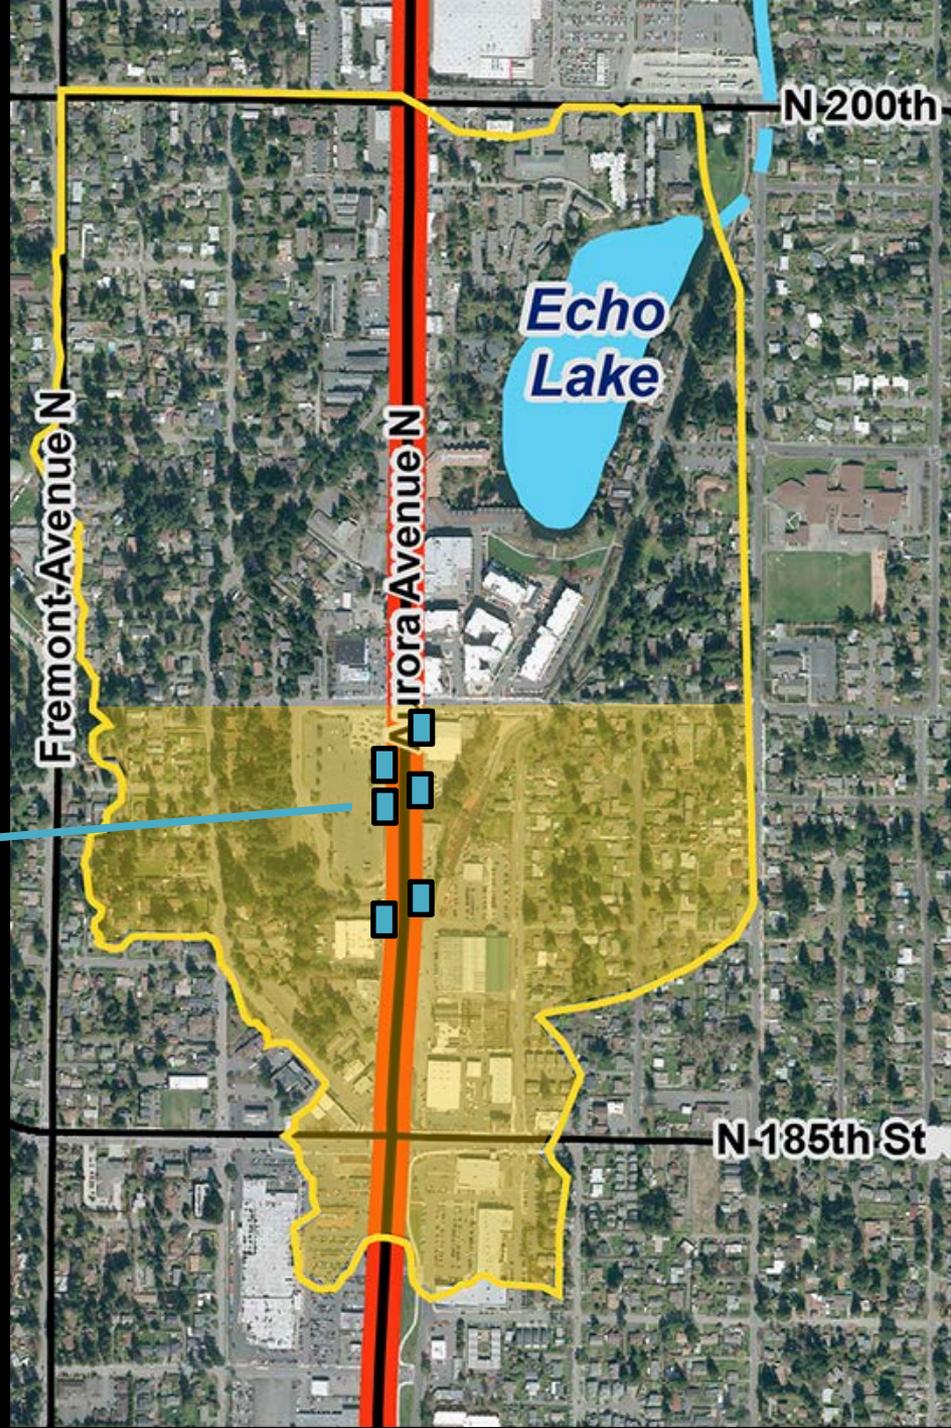
Bioretention Planter Boxes:

The retrofit included
Bioretention Planter
Boxes

- 60/40 sand/compost mix
- Designed for enhanced treatment
- Runoff from roadway enters catch basin system before entering main planter box
- Concrete lined = no infiltration
- Perforated PVC pipe underdrain

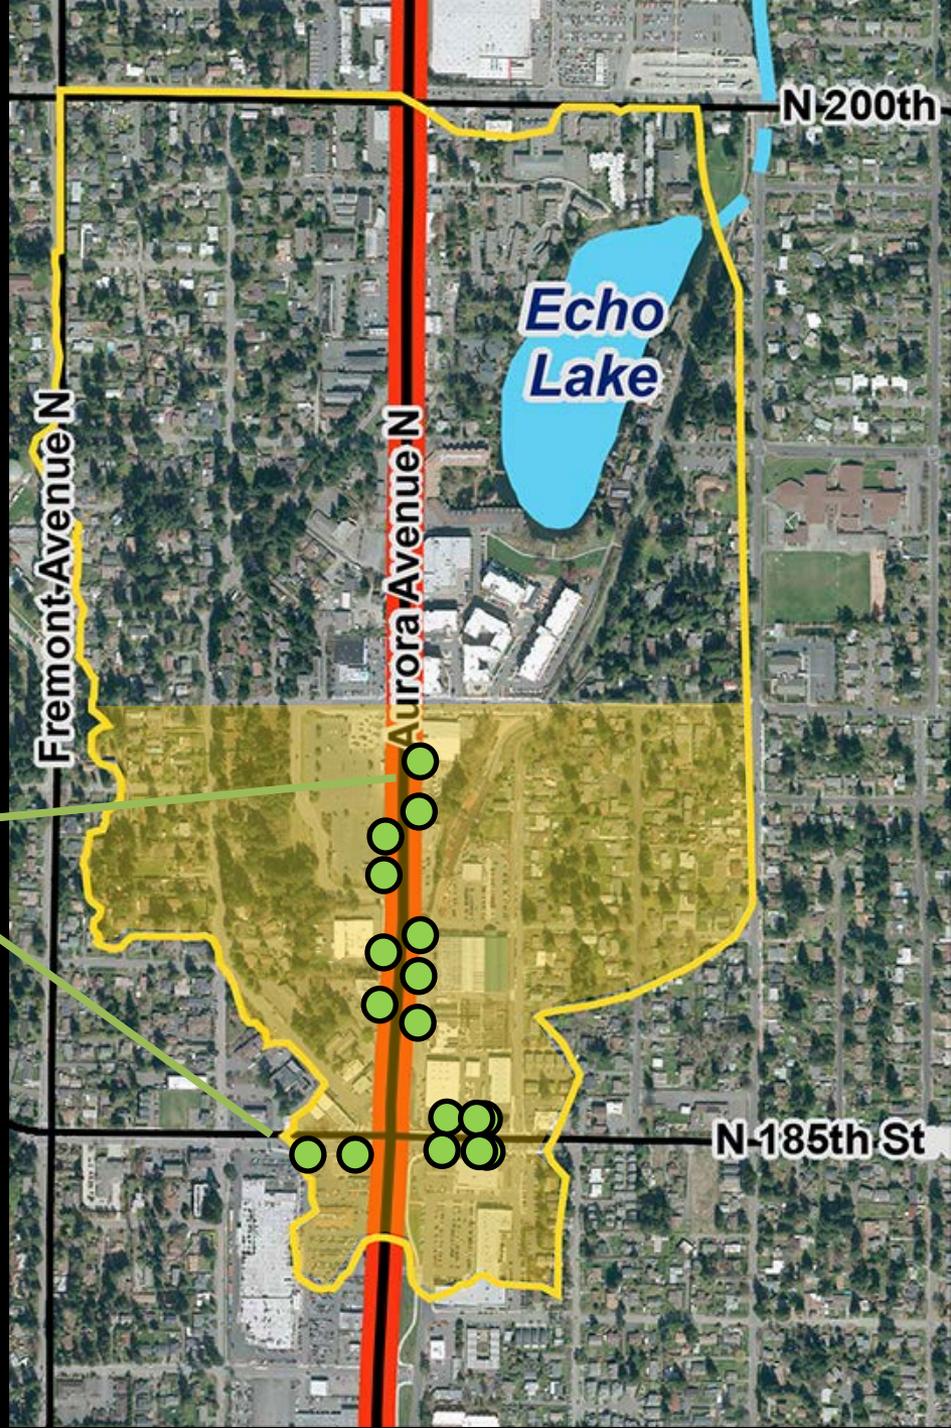
Filterra:

The retrofit also included Filterra

- Proprietary media
- Designed for enhanced and phosphorus treatment
- Runoff from roadway enters directly into Filterra

- Concrete lined = no infiltration
- Perforated PVC pipe underdrain

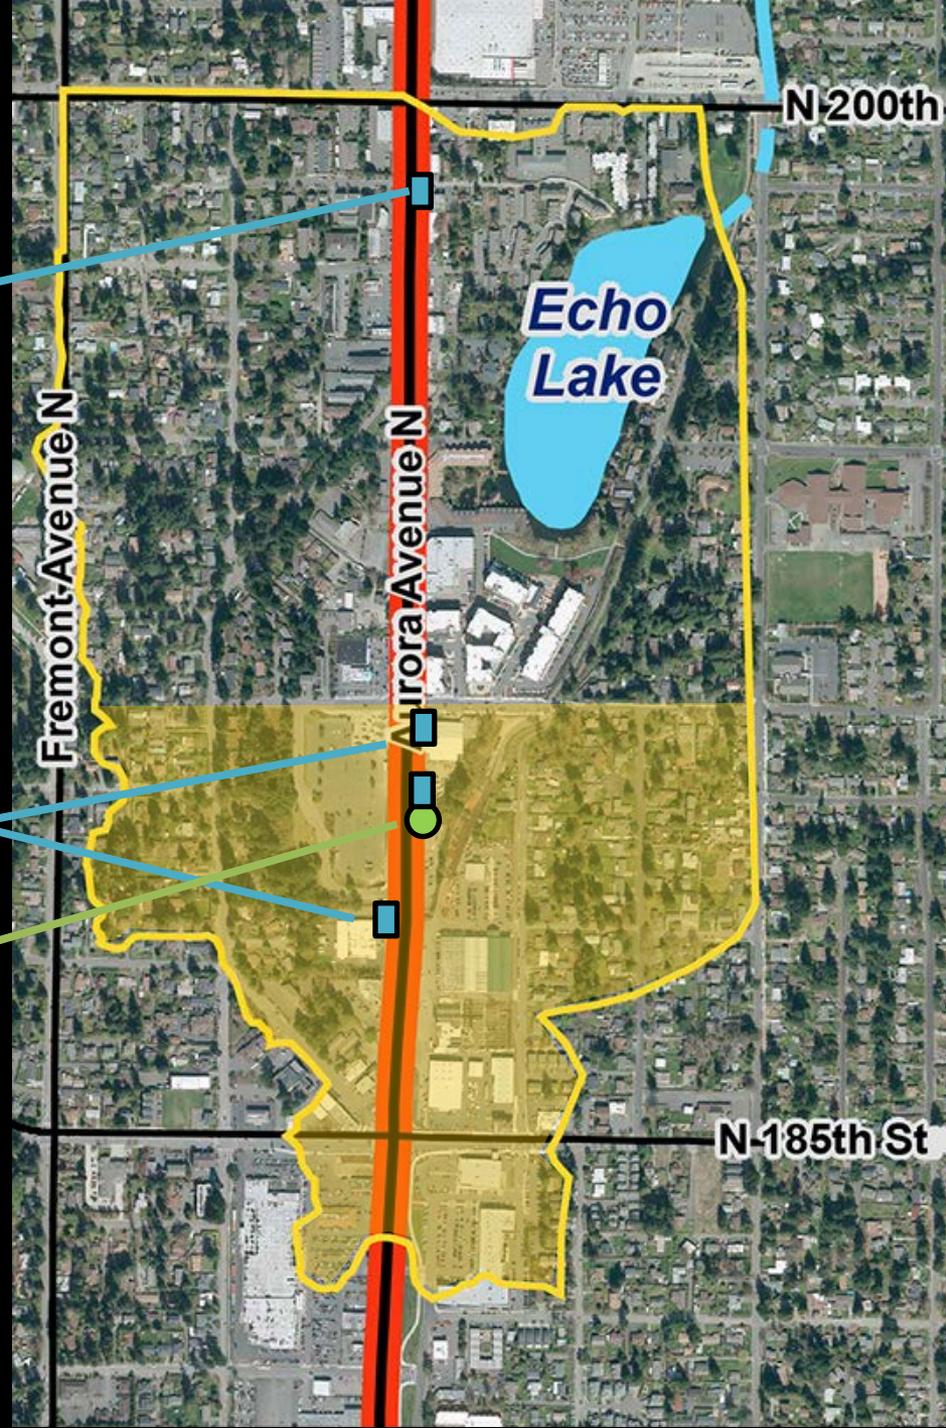
Basic study design:

samples at the inlet and outlet

2015 - 2017

5 to 8 storms

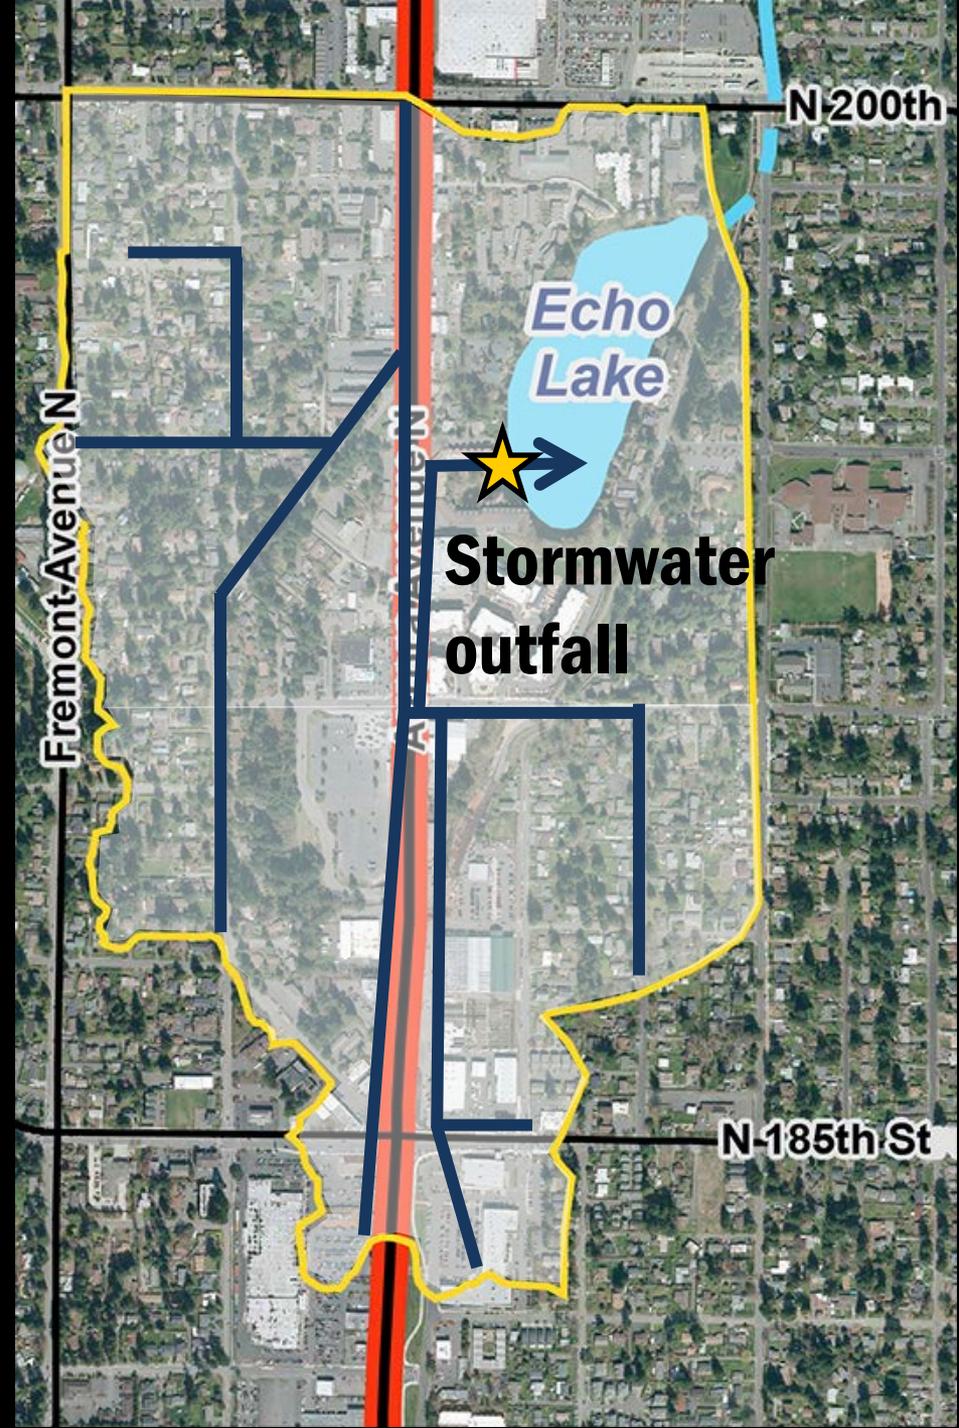
Echo Lake is part of a long-term monitoring program, and so these data were leveraged to compare water quality trends with retrofitting in the basin.

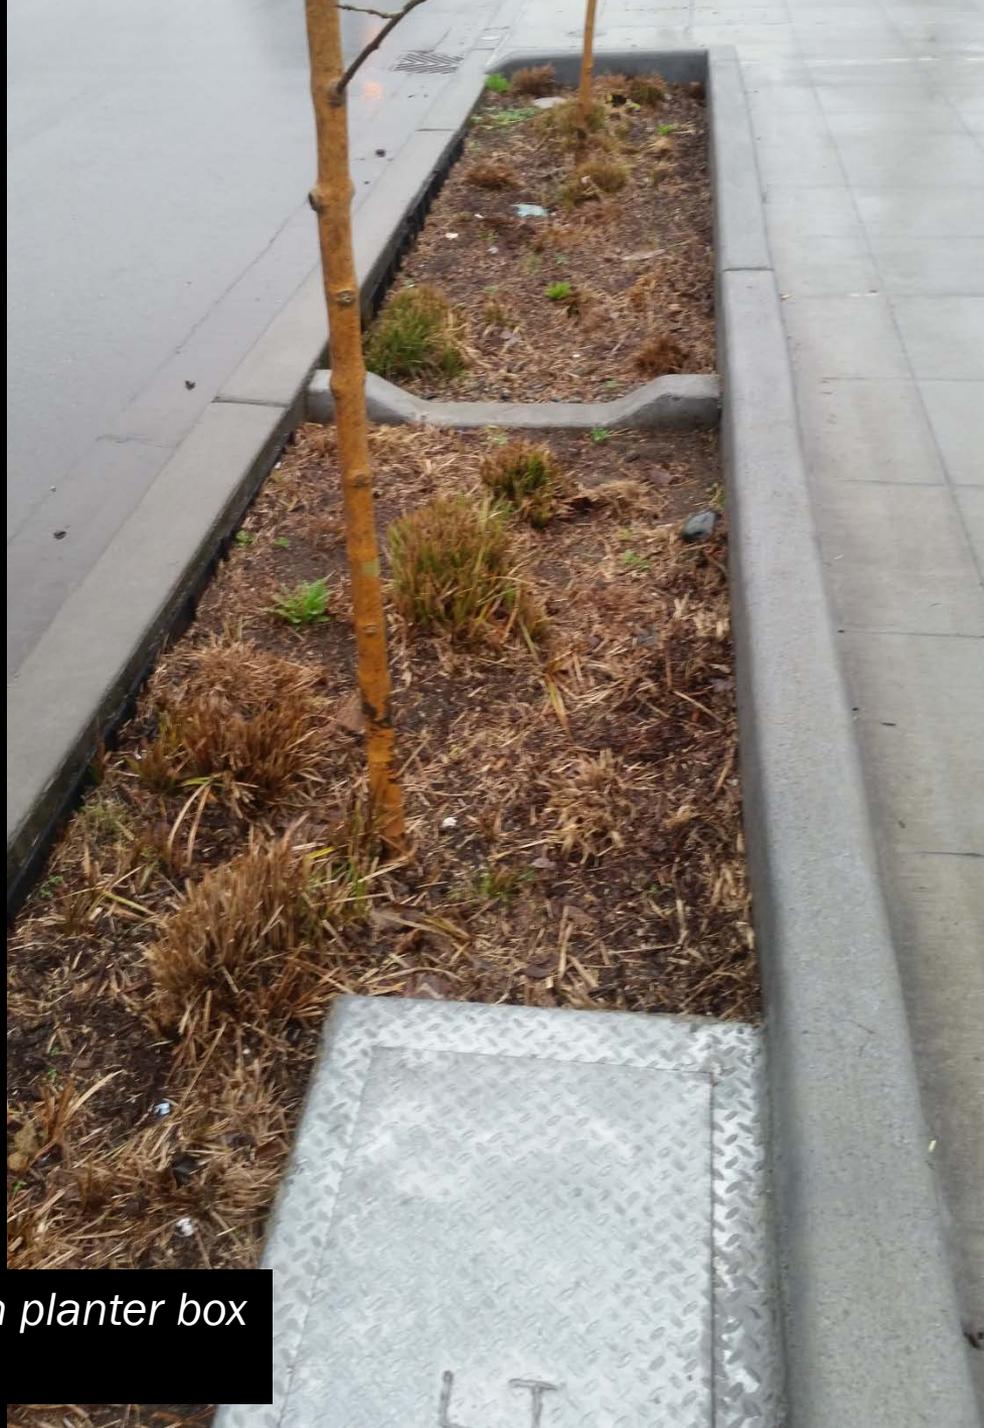
The first bioretention planter box looked pretty dry...

We looked in from the street, and saw dirt and debris had plugged the small curb cut, completely blocking the runoff from the highway. The other bioretention planter boxes were in a similar state.

We cleared all the curb cuts and watched the water start to flow. We talked with City of Shoreline and they scheduled a maintenance visit for the other bioretention planter boxes in the area.

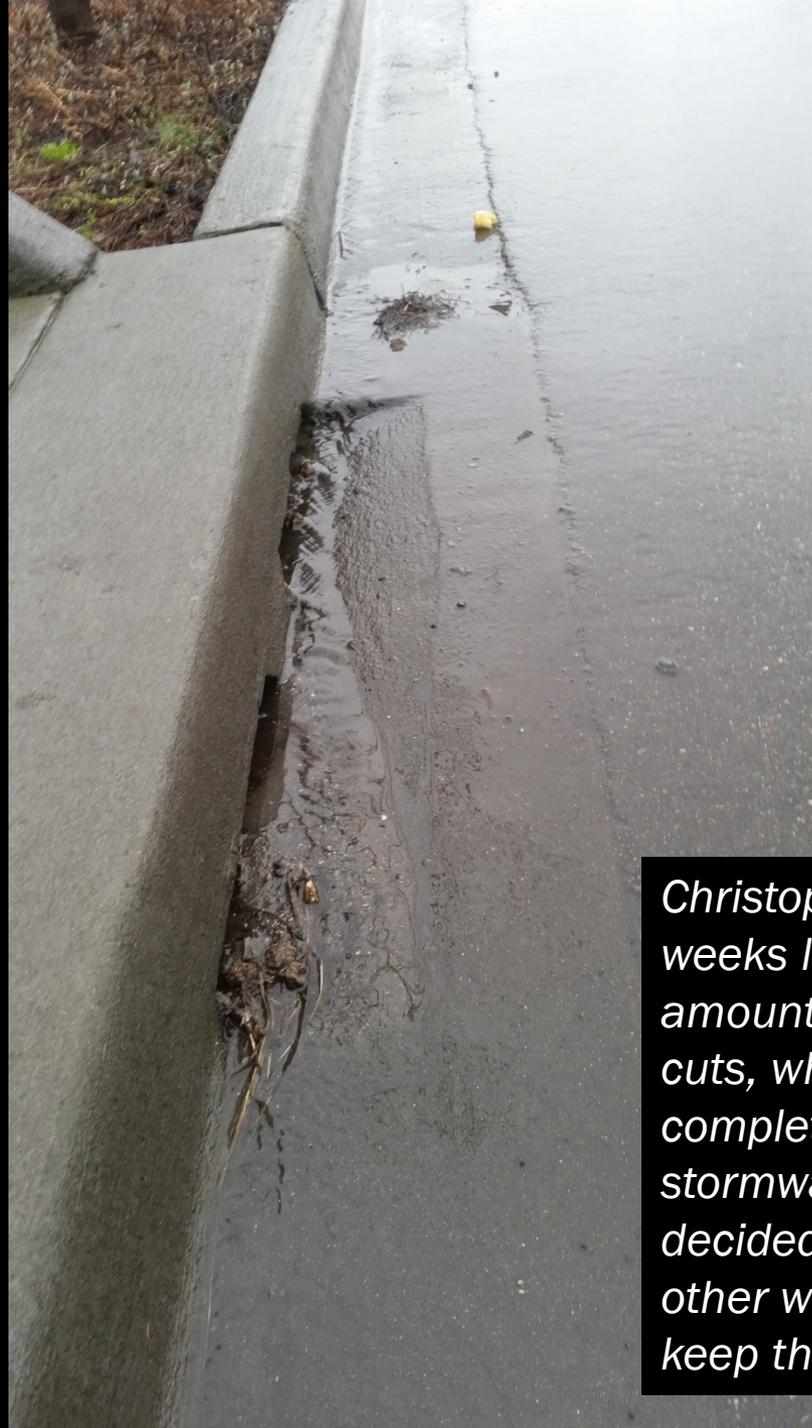
Christopher visited the site a few weeks later to find a small amount of debris in the curb cuts, which had again completely blocked the stormwater from entering. We decided to visit the site every other week at a minimum to keep the curb cuts clear.

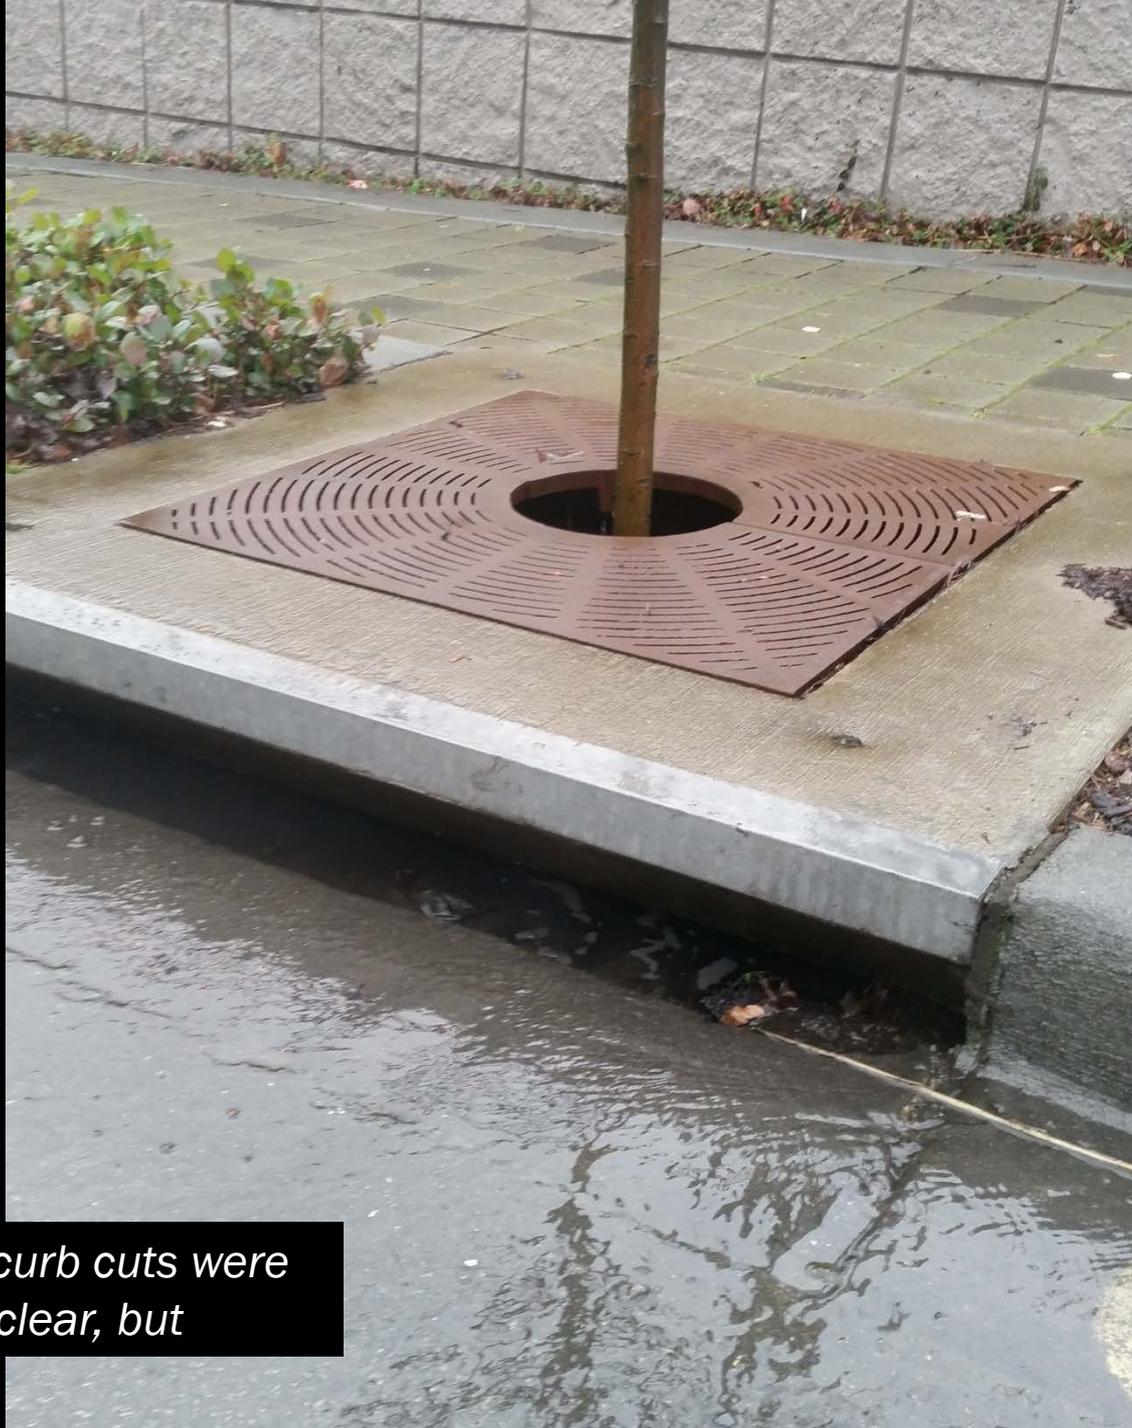
Now the Filterra curb cuts were bigger and were clear, but

When we opened up the lid, the Filterra was flooded. It was still flooded during our site visit a few weeks later, and so the City of Shoreline replaced the media that summer.

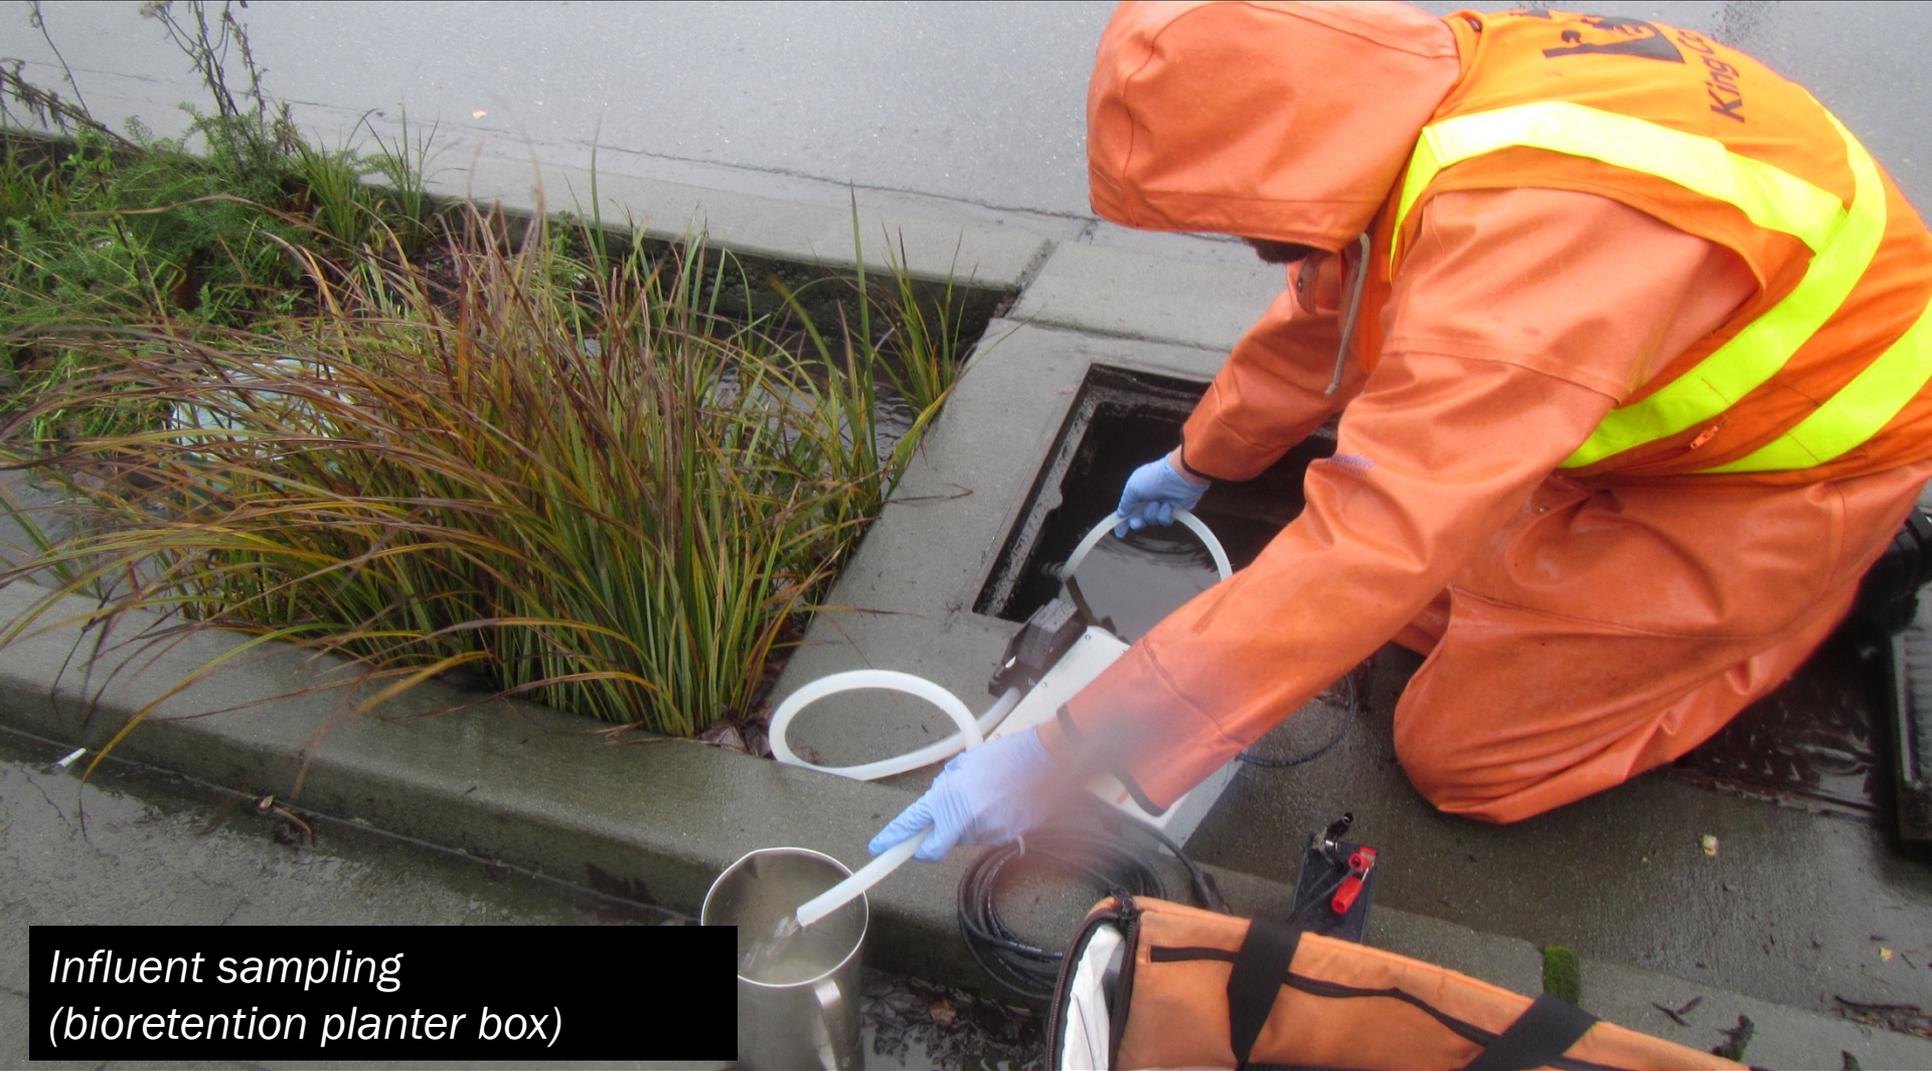
*Influent sampling
(bioretention planter box)*

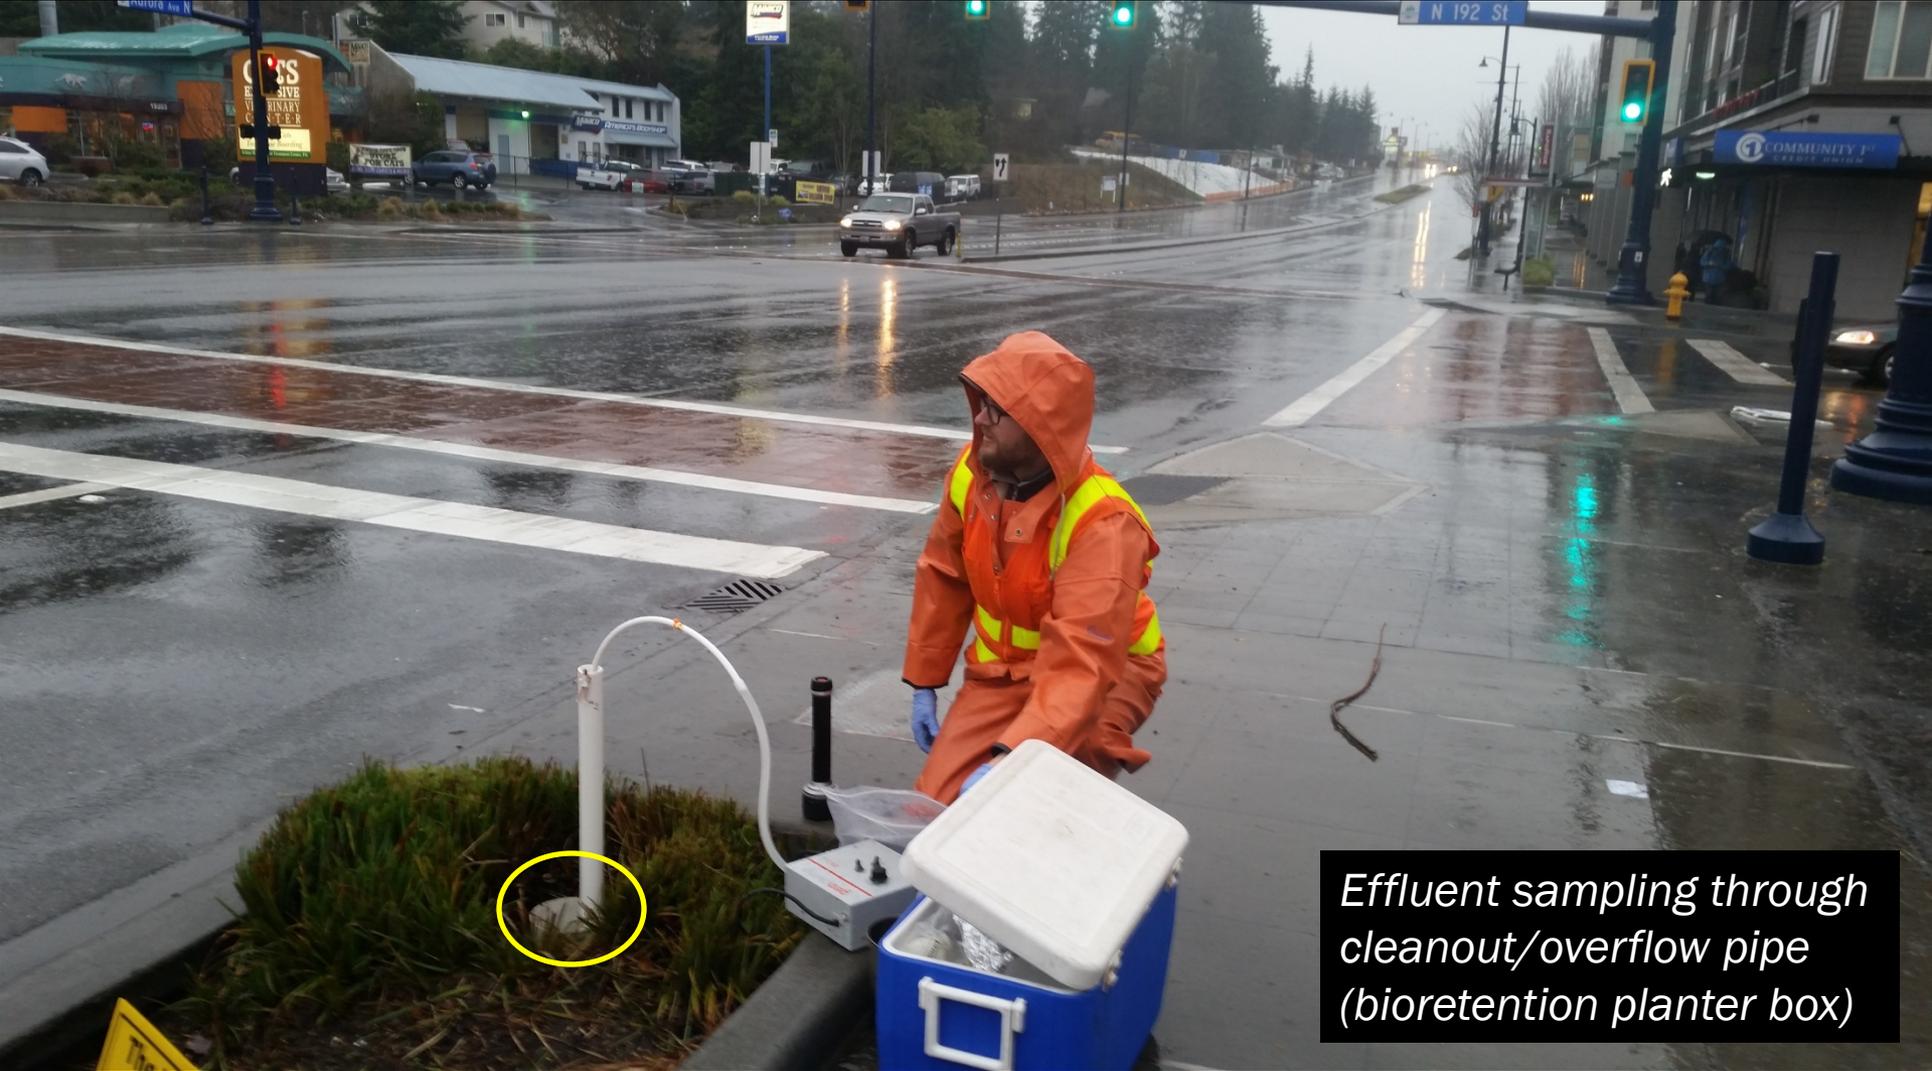
Effluent sampling through cleanout/overflow pipe (bioretention planter box)

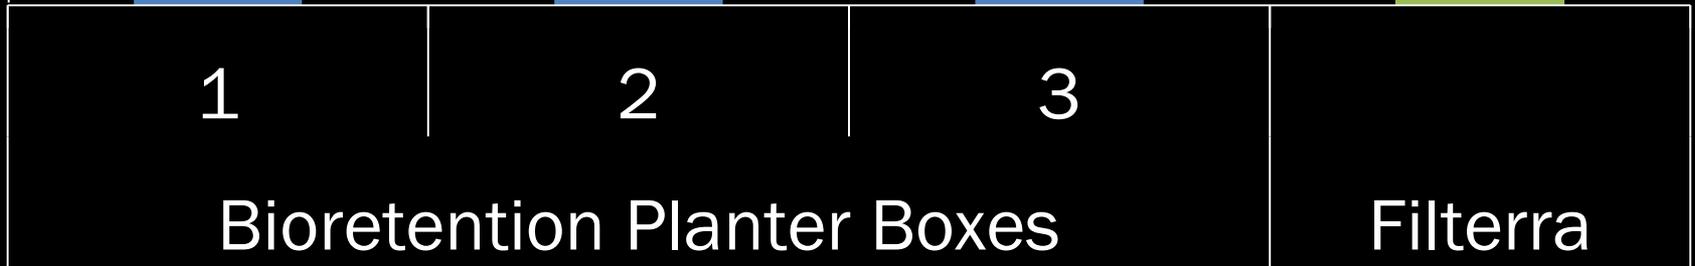
Total PAHs – Average Effluent

**Virtually
ELIMINATED!**

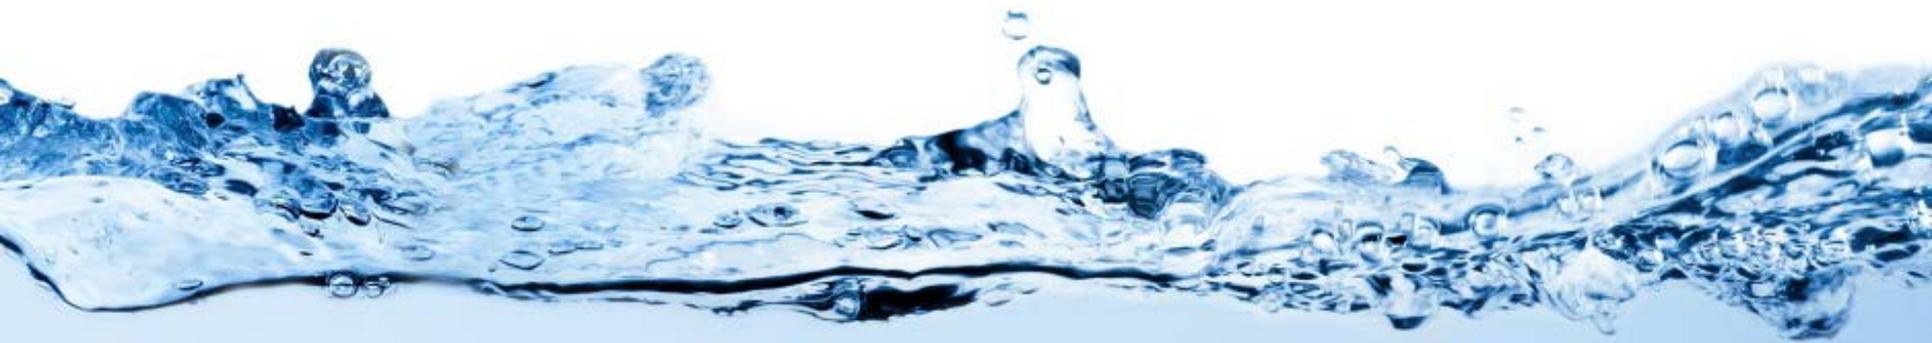
Total PCBs – Average Effluent

Great removal for both BMPs!

“Clean” laboratory water ~100 pg/L

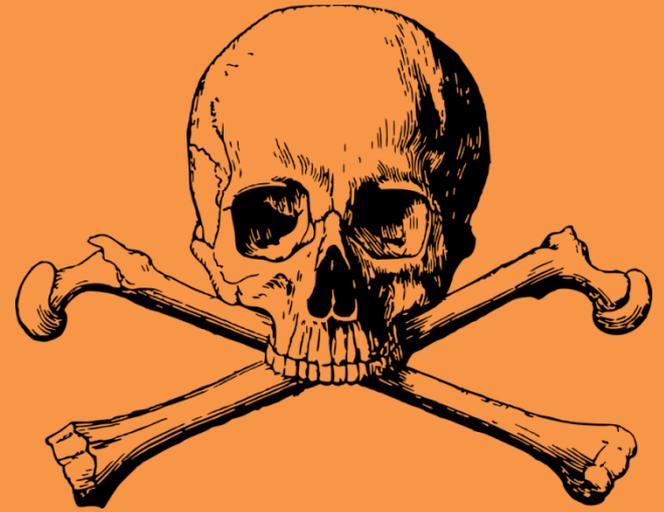
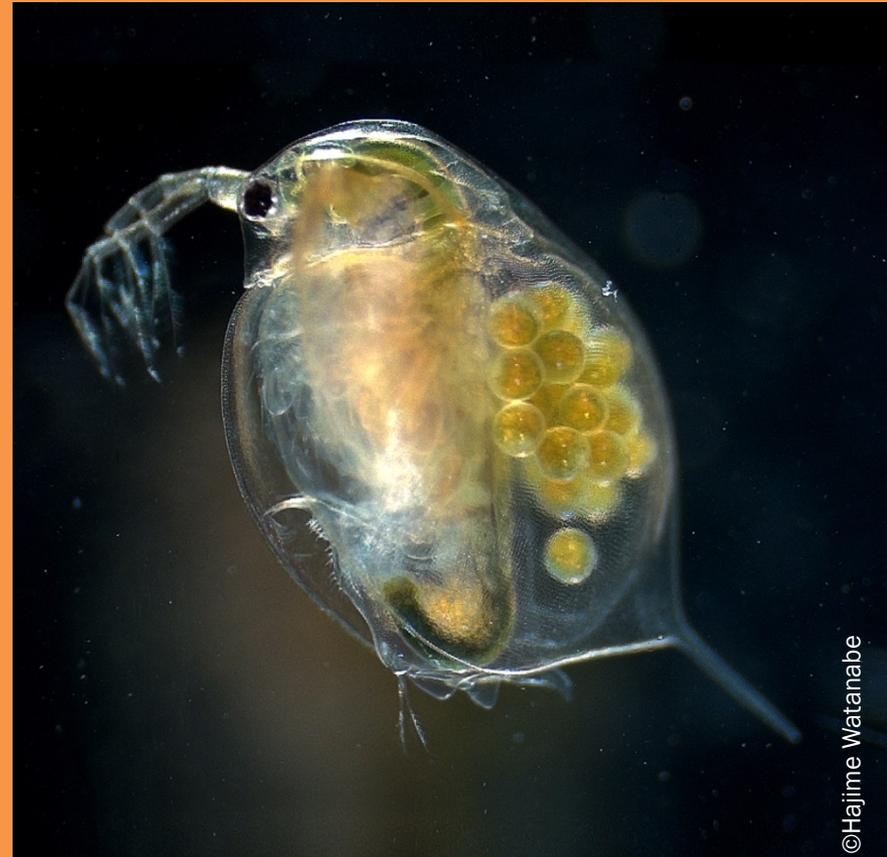
Toxicity tests conducted on daphnia for four storms at one bioretention planter box.

Toxicity did not often occur at this site, but when it did, the bioretention planter box was able to successfully reduce toxicity

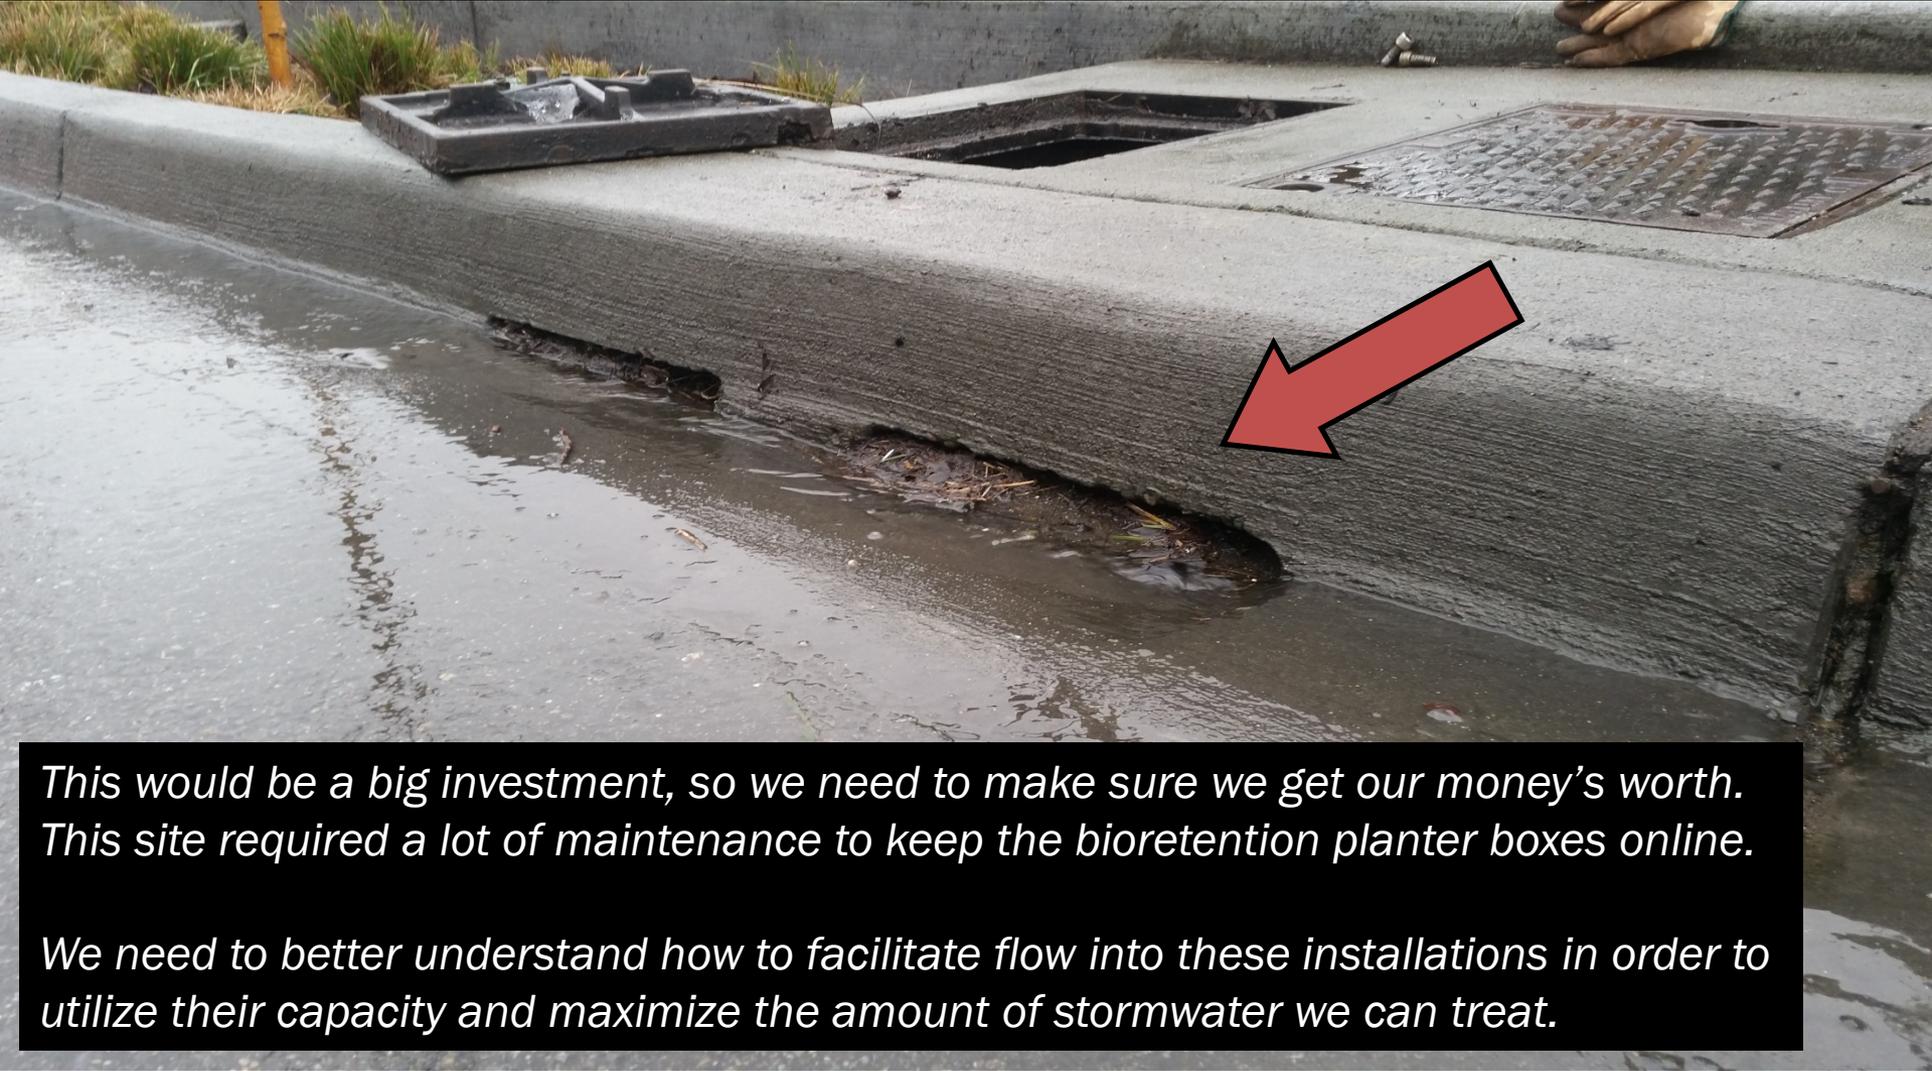
This would be a big investment, so we need to make sure we get our money's worth. This site required a lot of maintenance to keep the bioretention planter boxes online.

We need to better understand how to facilitate flow into these installations in order to utilize their capacity and maximize the amount of stormwater we can treat.

Larger curb cuts (like the Filterra here) don't get blocked as easily and require less maintenance.

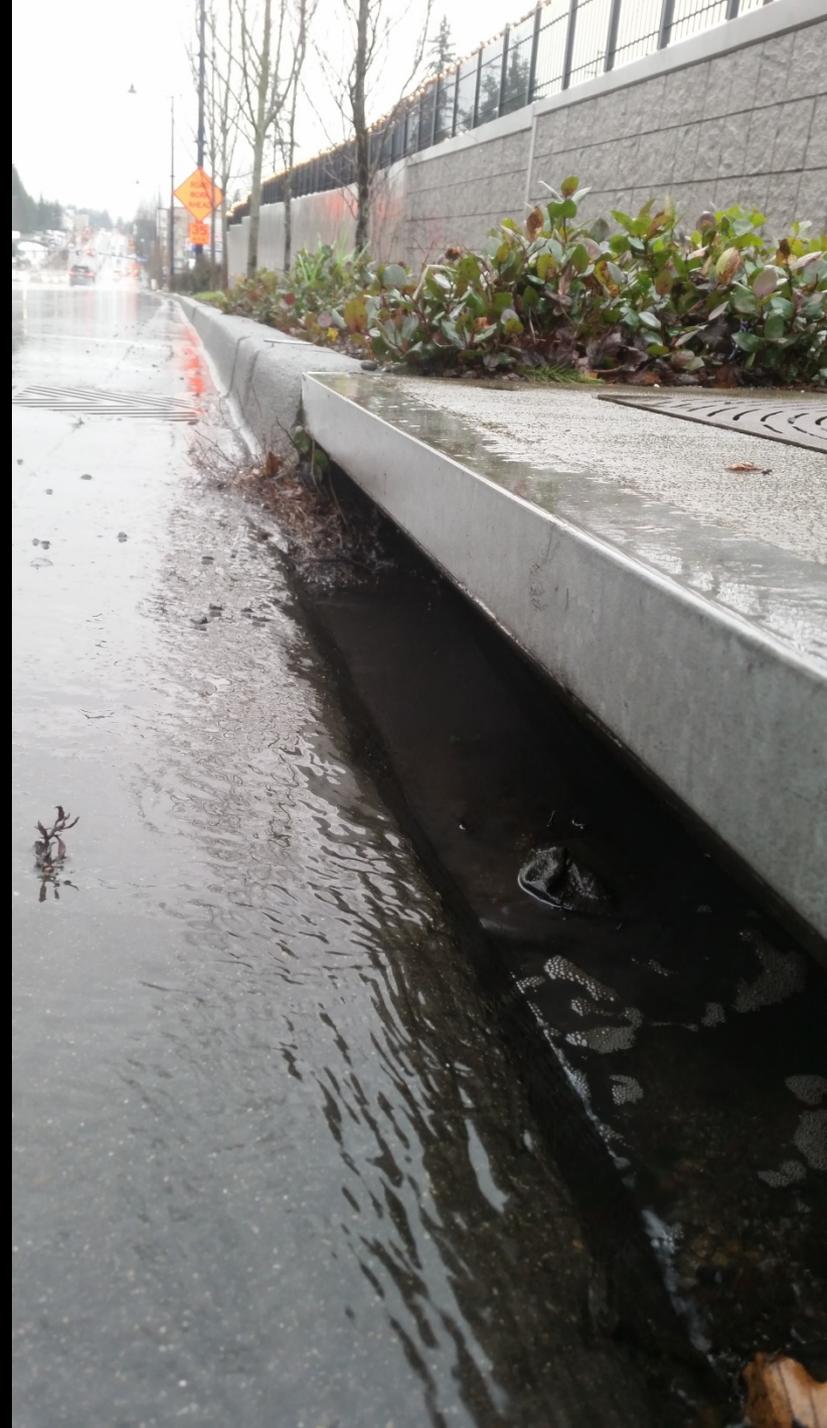
But the Filterra had their own issues. The Filterra were clogged again during the last few sampling attempts. This means media replacements have been needed every 2 to 3 years at this site.

Regular inspections are needed to verify whether the anticipated maintenance schedule will really work at a given site. And we want to make sure these are flowing because they treat stormwater pretty well...

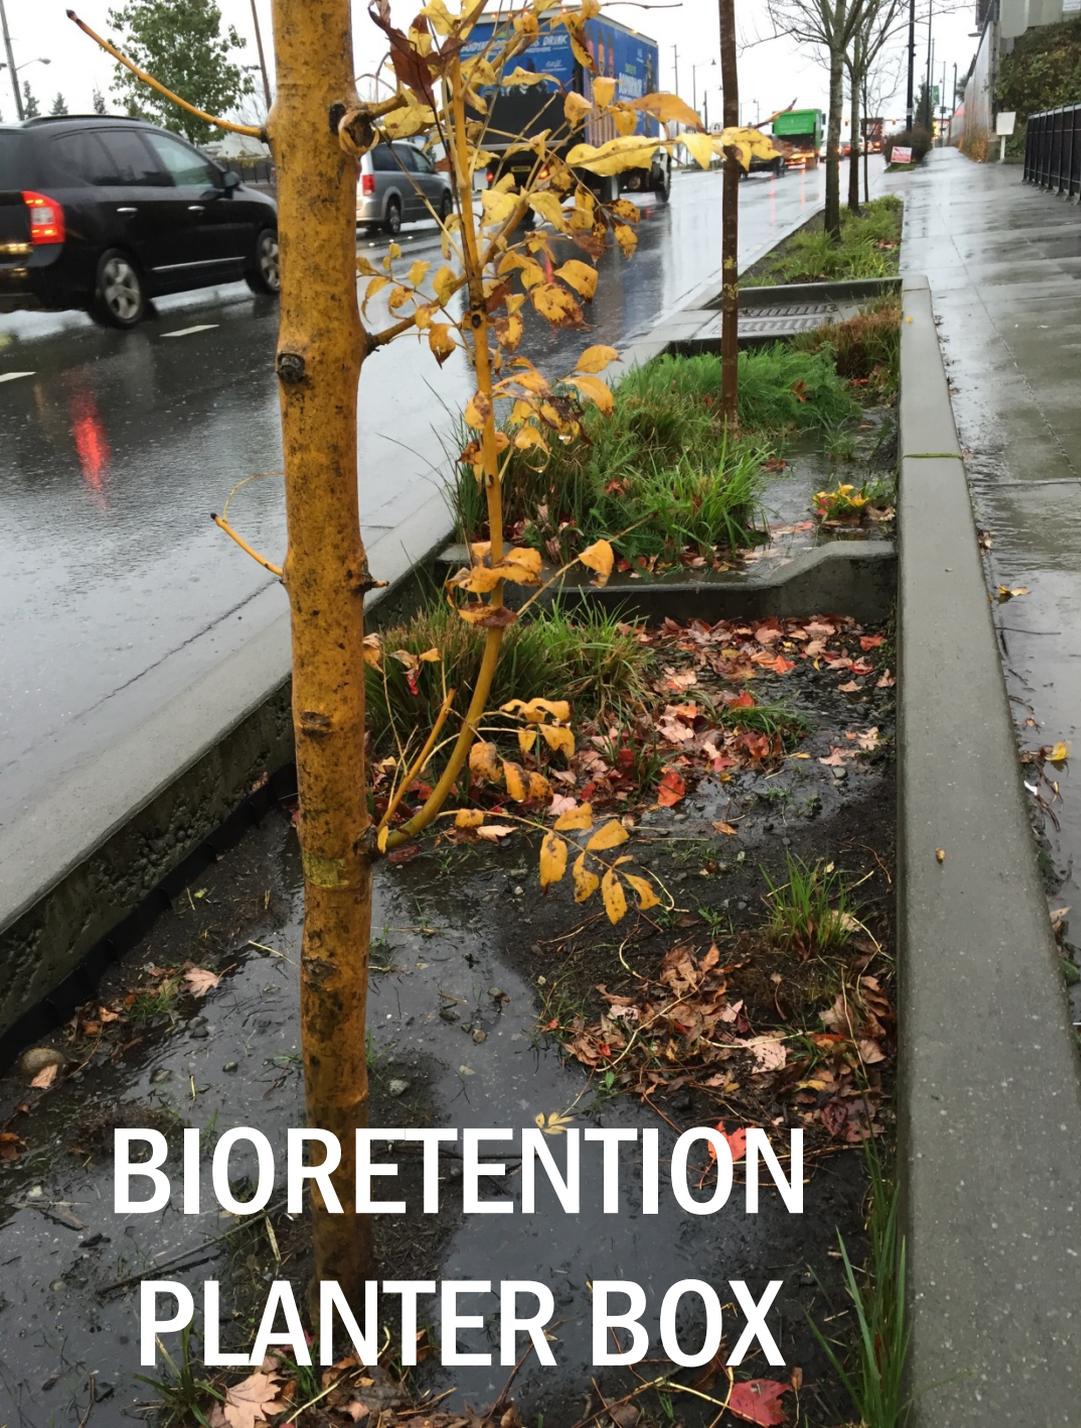
BIORETENTION PLANTER BOX

Suspended Solids

Dissolved Zinc

PAHs

PCBs

Toxicity

Flow

Dissolved Copper

Phosphorus

**Bioretention can
treat your
stormwater...**
