Eastern Washington Stormwater Effectiveness Studies

Technical Evaluation Report (TER)

Street Sweeping and Catch Basin Cleaning Comparison

Study Classification: Operational BMPs

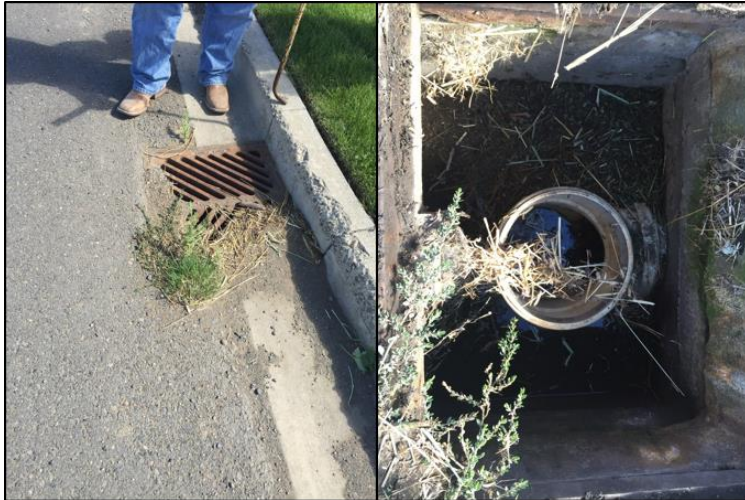
Figure 3.3 Proposed study area: typical roadway and catch basin sediment accumulation

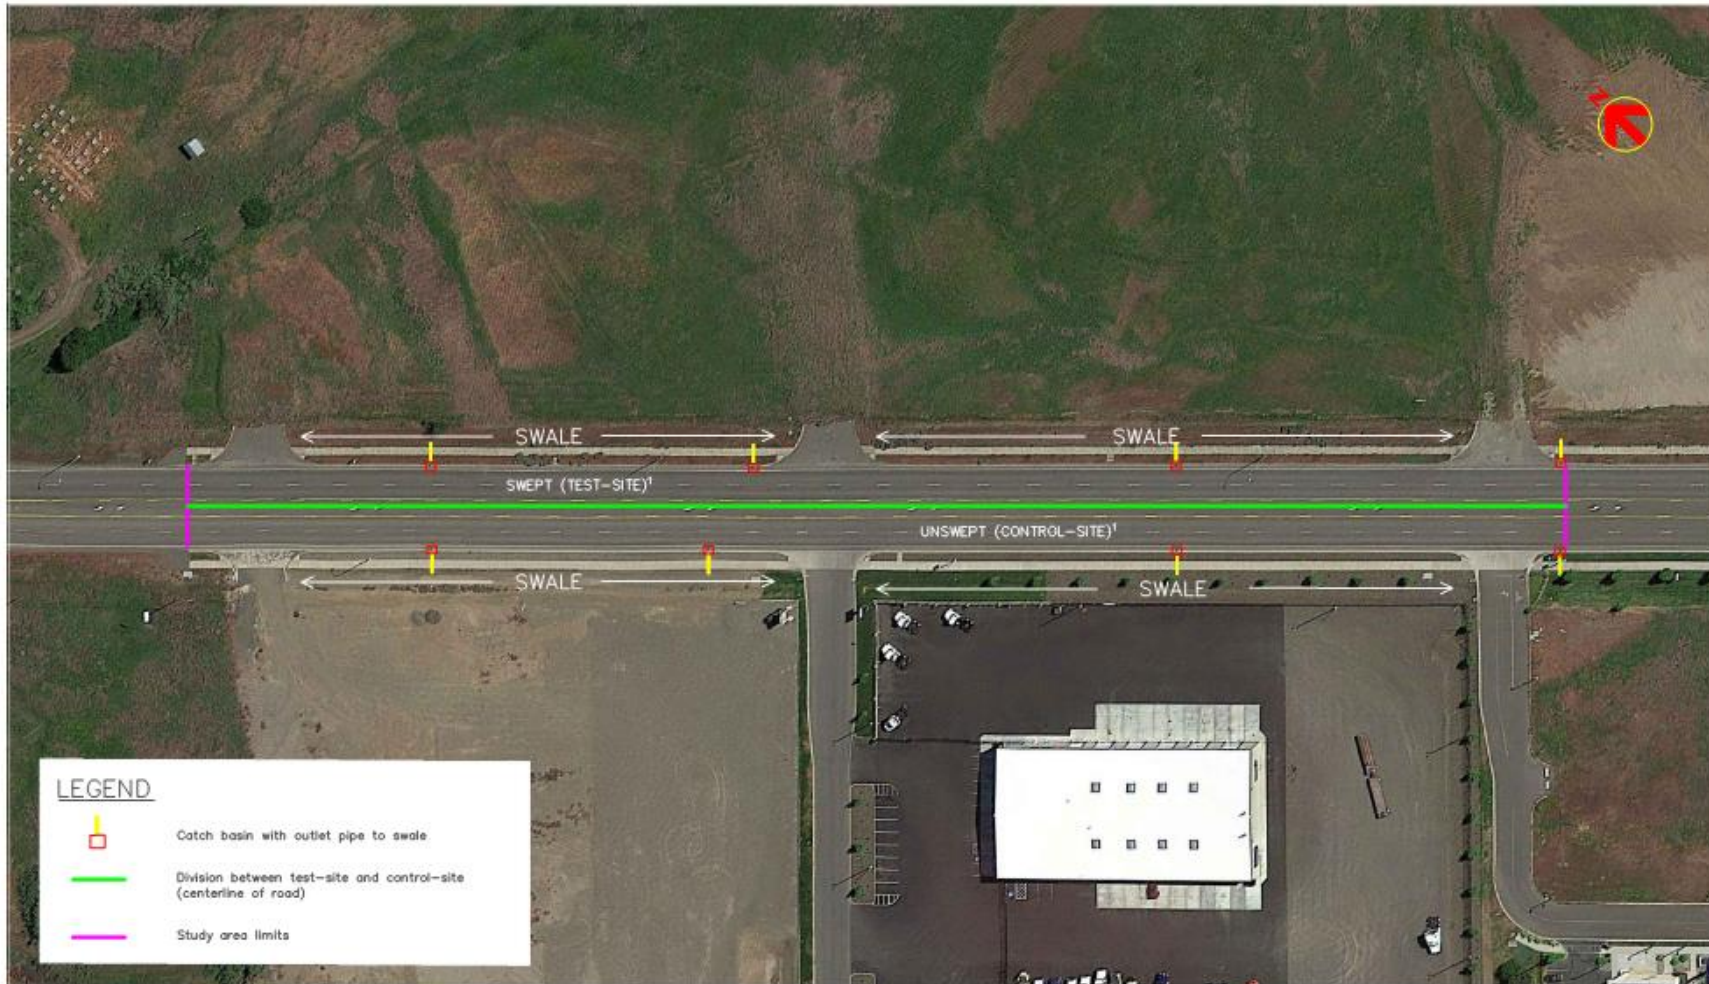
Figure 3.6 Aerial view of the proposed study area showing the locations of the test site and control site

¹ The test-site and control-site will switch to the other sides of the road for year two.

The proposed study area was a 1065-foot section of road on State Route 97 located in Ellensburg, Washington between Desmond Road and West University Way (Figure 3.6). This principal arterial is a major hay hauling route and the land use in the study area is primarily commercial and light industrial. The road has four 12-foot lanes, a 12-foot turning lane, and two 4-foot shoulders (Figure 3.7). The speed limit on the road is 40 mph with an approximate average daily traffic (ADT) of 4000. The study location was selected because the proposed test site and control site provide equivalent areas for comparison including:

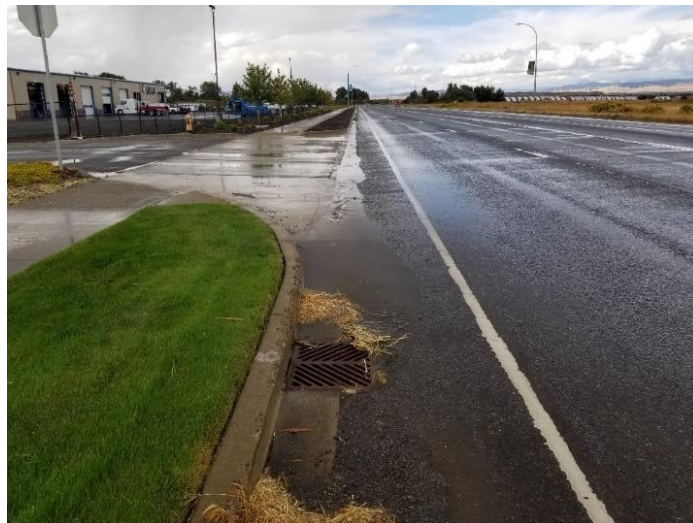
Figure 3.9 Approaches contribute runoff to catch basins

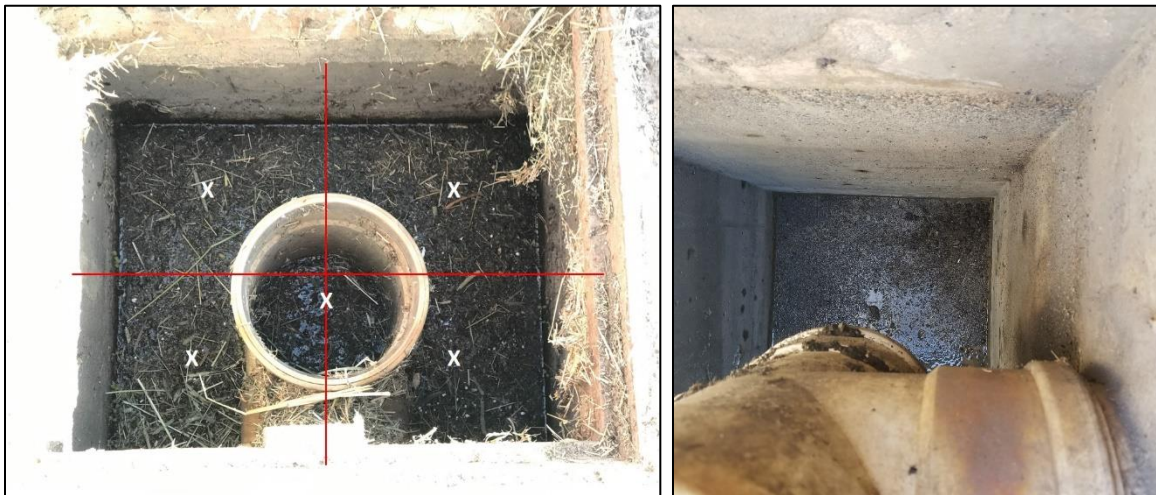
Figure 5.2 Catch basin sediment depth: measure in five locations full (left) and empty (right)

The depth of sediment in each catch was measured using a fiberglass, telescoping survey rod with hundredths of a foot gradations. This included measuring from the rim of the catch basin to the top of the sediment in five different locations (Figure 5.2) before cleaning catch basins and subtracting these measurements from the depth of the catch basin empty. The average sediment depth in each catch basin was determined by averaging the five measurements. The SOP for measuring the sediment depth is located in Section 8.1.1 of the QAPP.

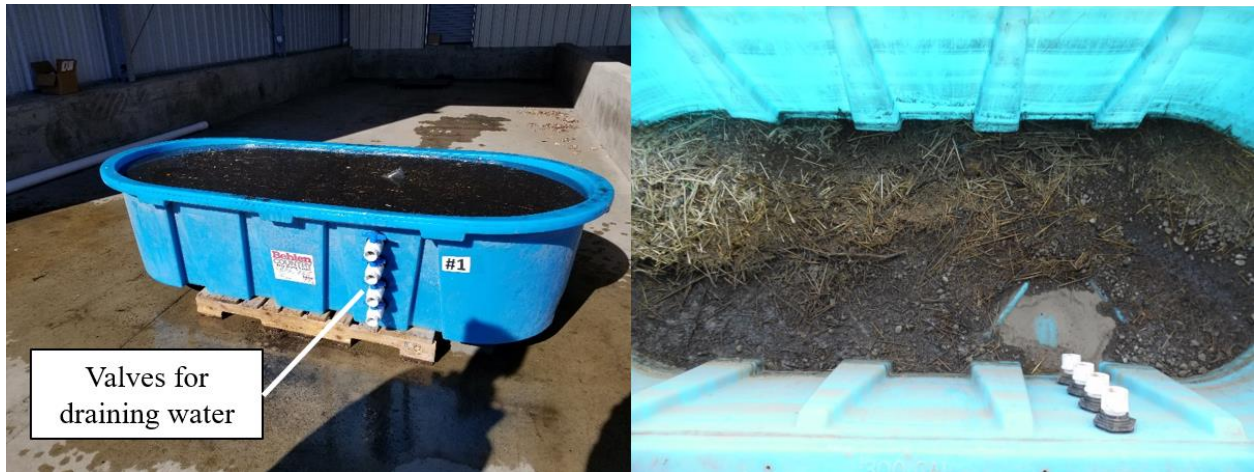
Figure 5.4 Dewatering Basin Prior to Settling (Left) and Following Dewatering (Right)

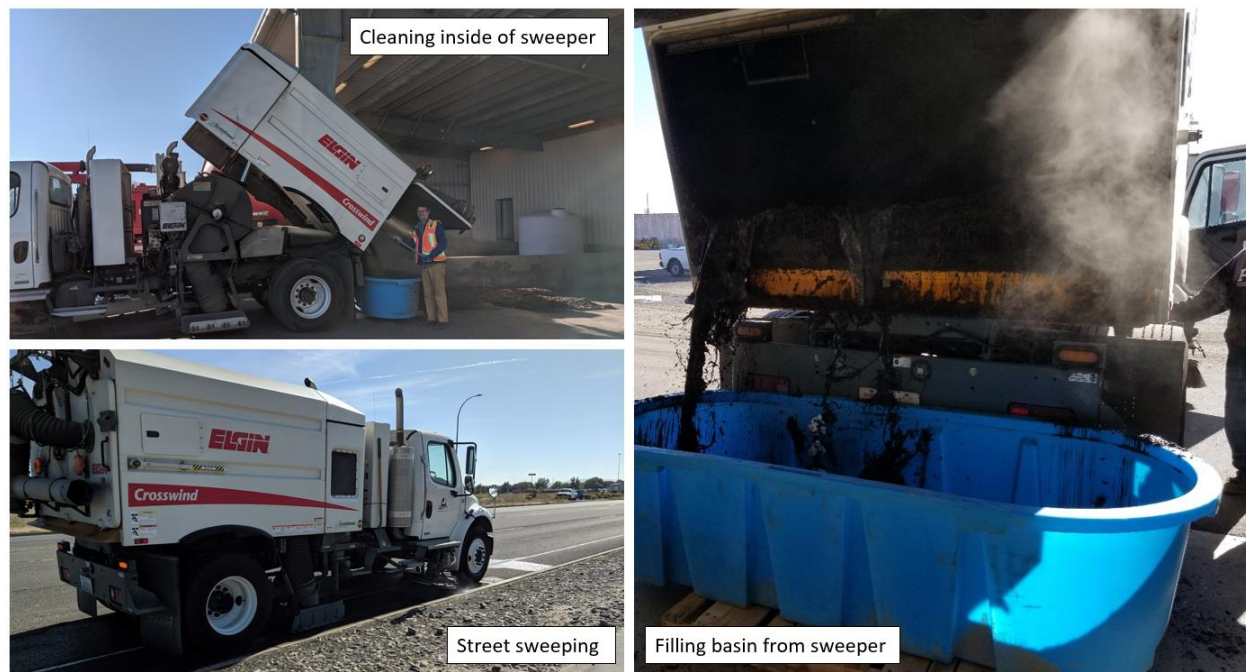
Figure 5.5 Roadway Sediment Accumulation Data Collection

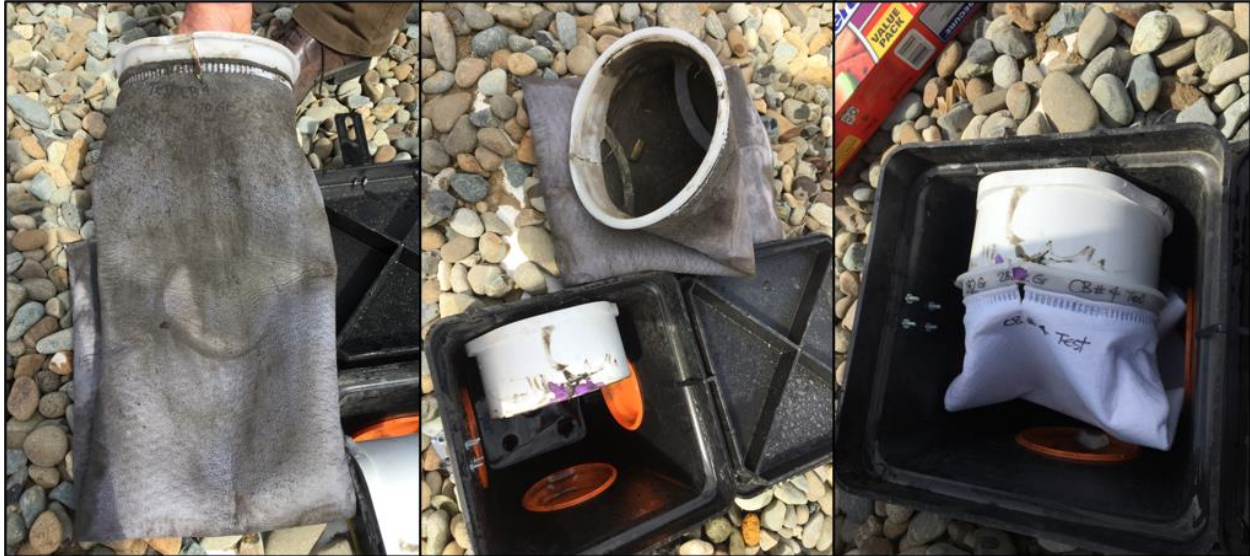
Figure 5.7 Catch Basin Socks: after 2 months use (left), uninstalled (middle), installed and new (right)

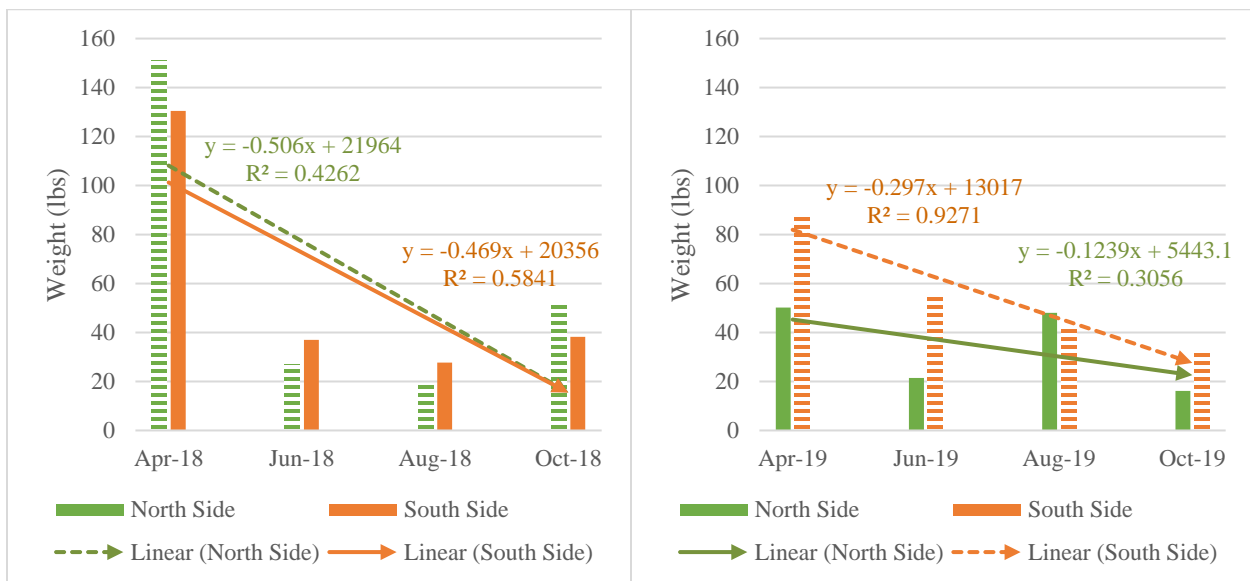
Figure 7.5 Comparison of Catch Basin Sediment Dry Weight Collecting during 2018 (left) and 2019 (right)
 Note: Hatched bars indicate test side and solid bars indicate control side.

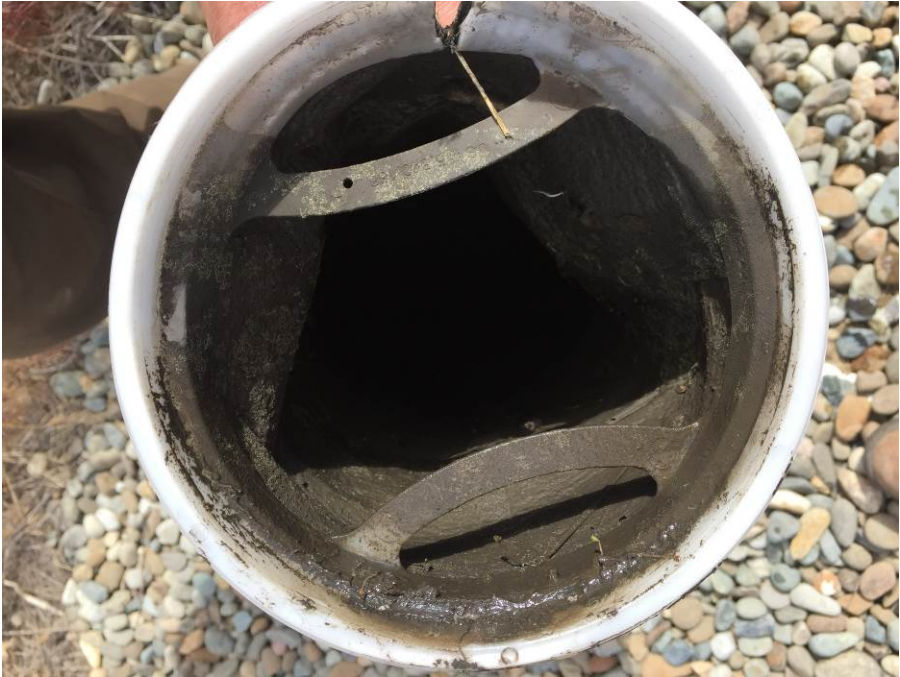
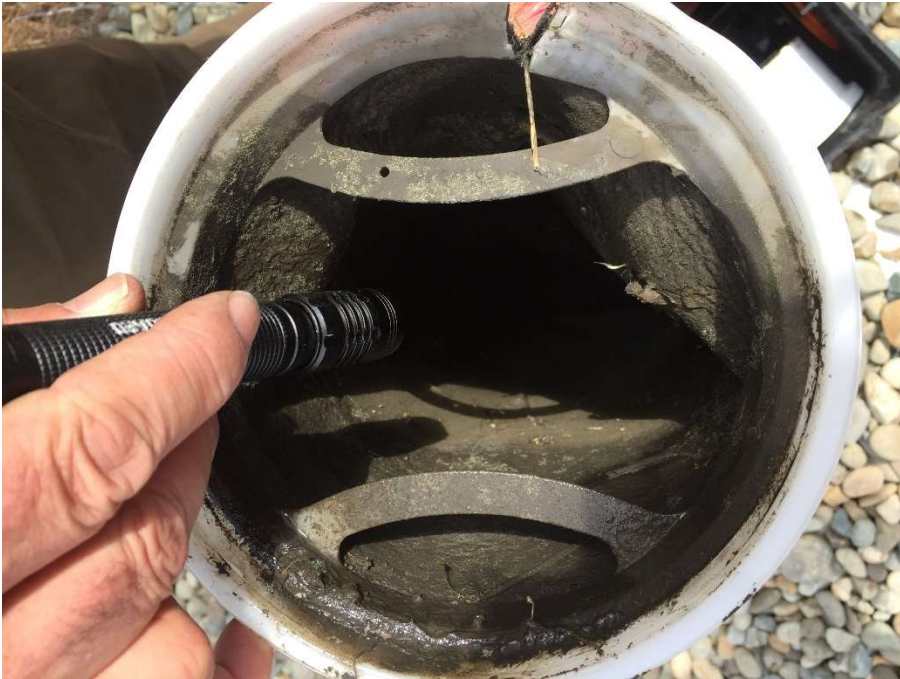
Sump sock for CB 4 shown above. Sump sock was removed and placed in a bag for dry weight and PSD sampling. Sediment accumulation reflects washout from the catch basin upstream between the April sampling event and June 19th.

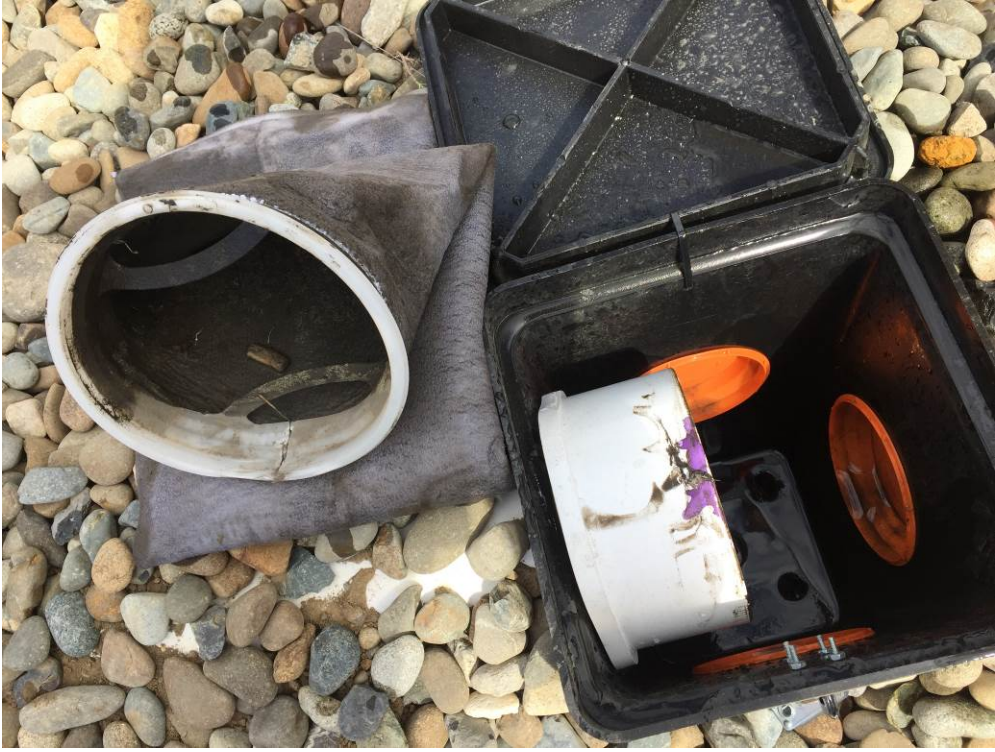
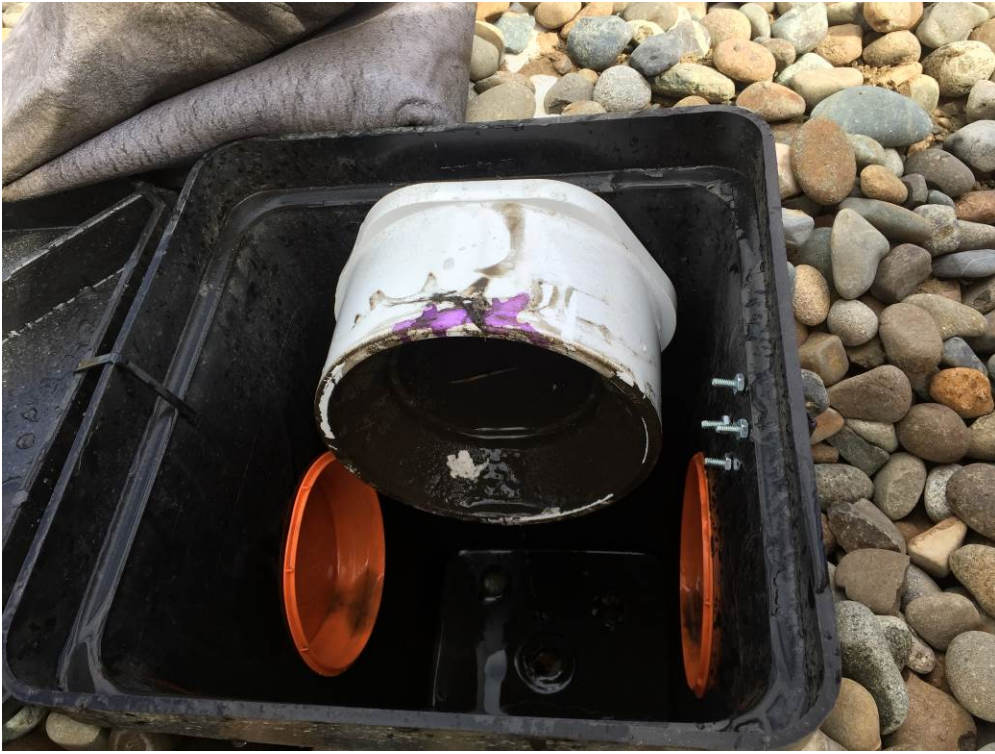
The same sump sock is shown next to the sump basin from which it was removed. The inside of the outlet pipe is coated in the same sediment as was in the sock. Care was taken not to lose any of the sediment in the pipe when removing the sock.

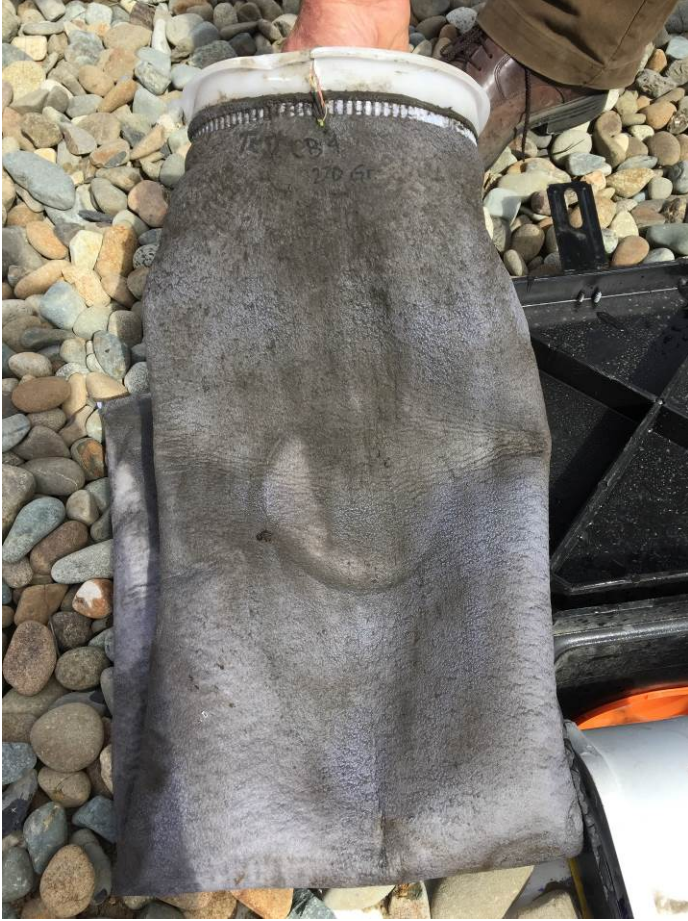
The photo above shows the removed sock with “Test CB4 270 gr” written on the sock. 270 grams is the clean/tare weight of the sock prior to when it was installed.

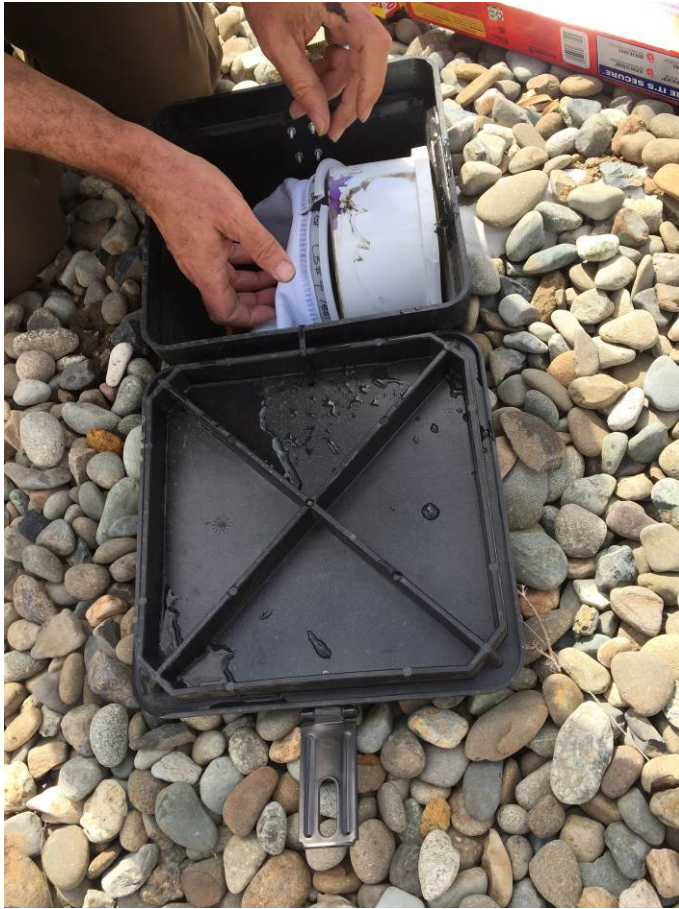
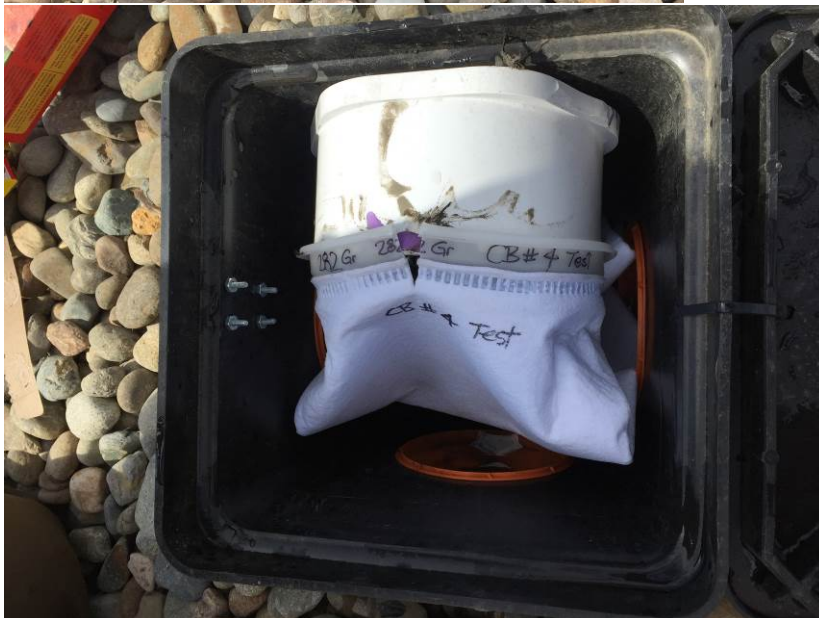
The above two pictures display the new clean sock being installed. The sock is folded and placed in the sump box, and gorilla tape/duct tape is placed around the plastic ring and across the cut in the sock (done intentionally to get the sock onto the pipe). The sock fits tightly onto the pipe.

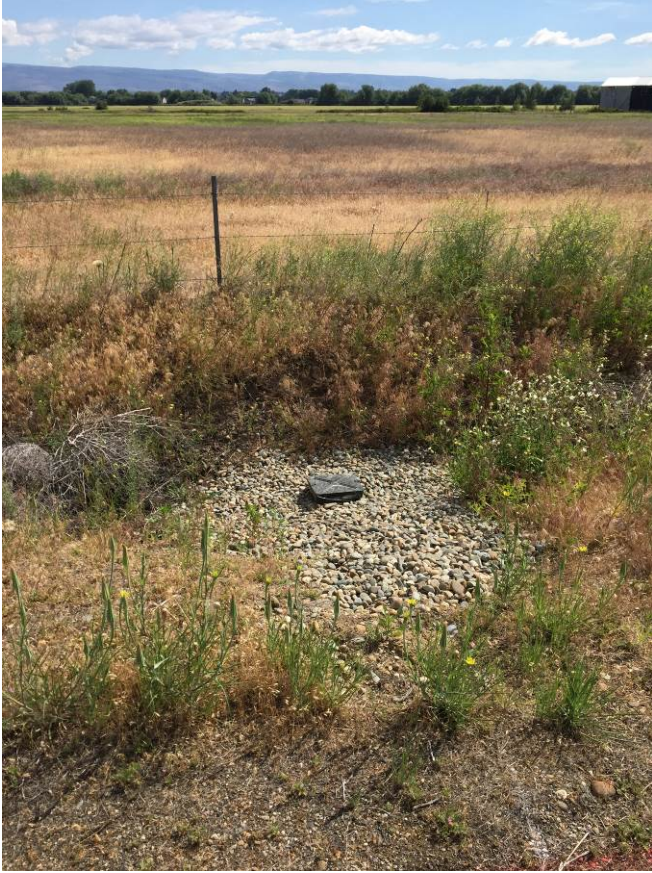
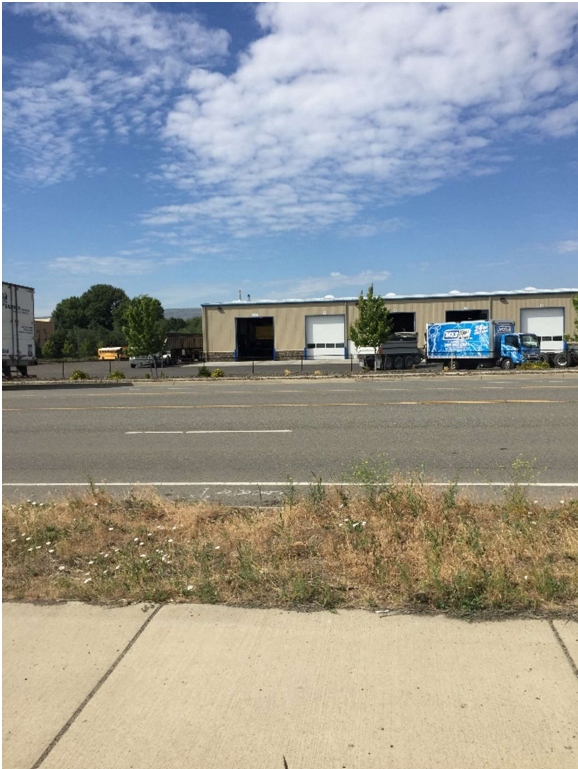
Photo of a closed sump box at the site and the upstream/area across the street

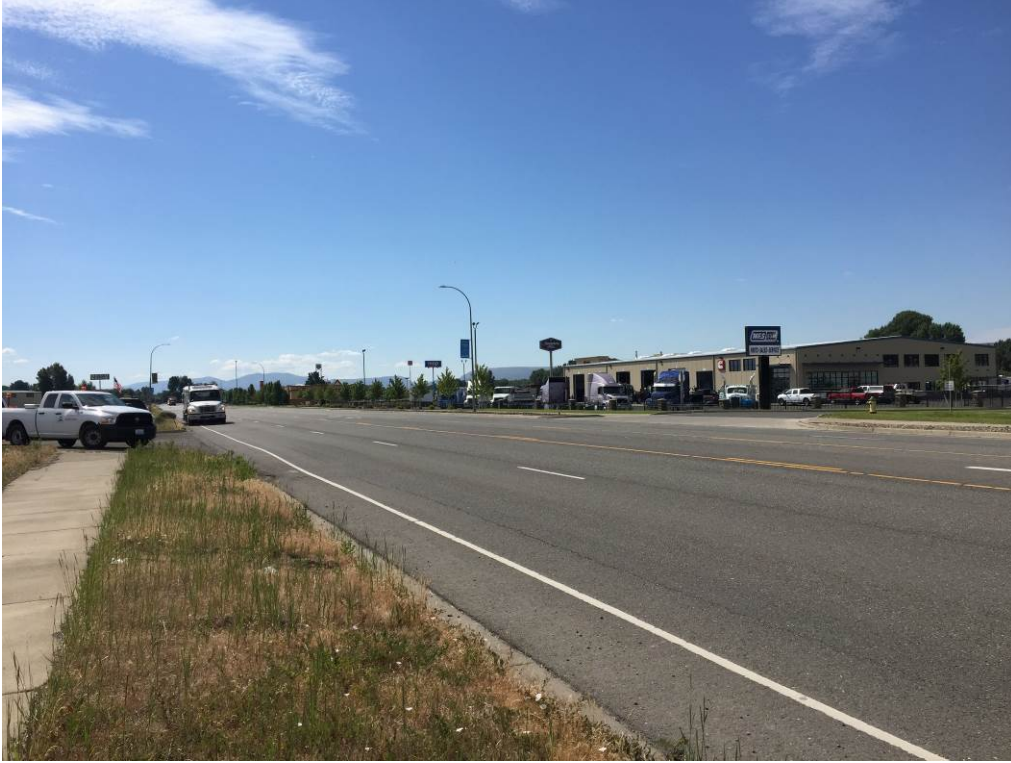
Picture of sweeper on the test side of the road (north)

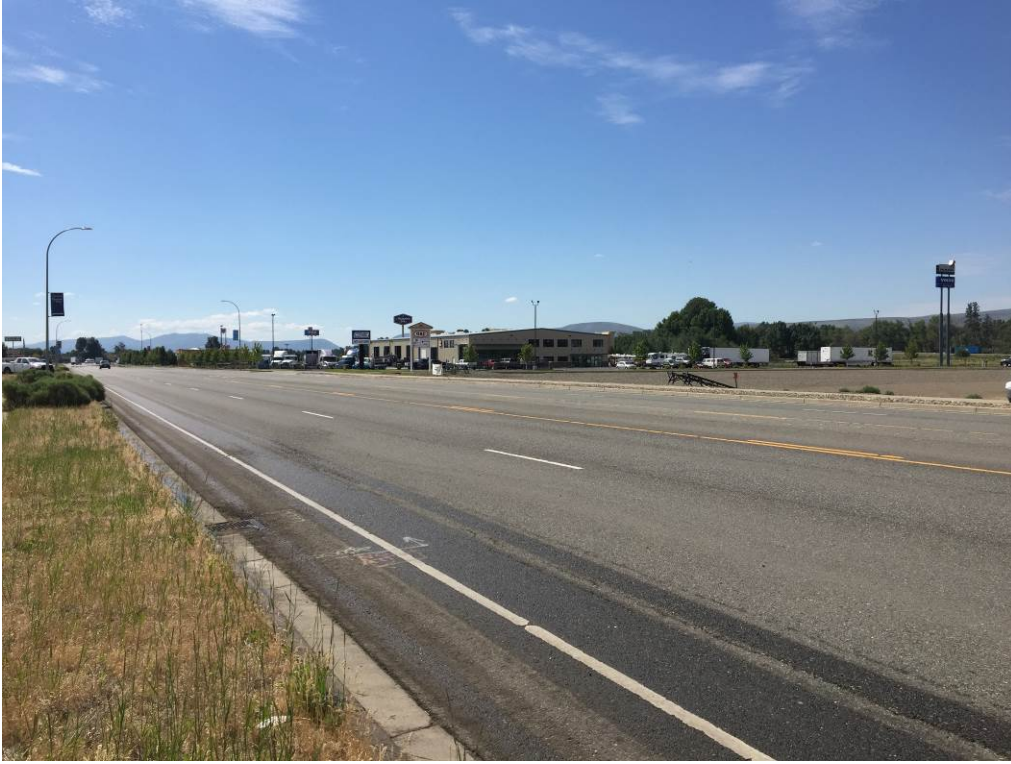
Picture of the road after swept

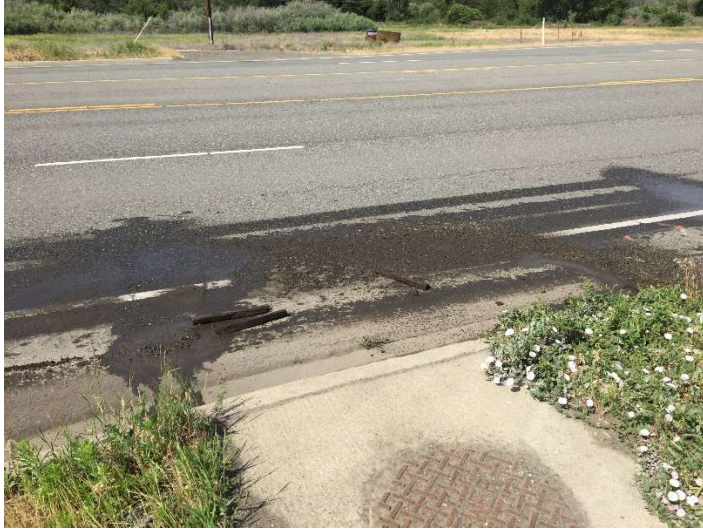
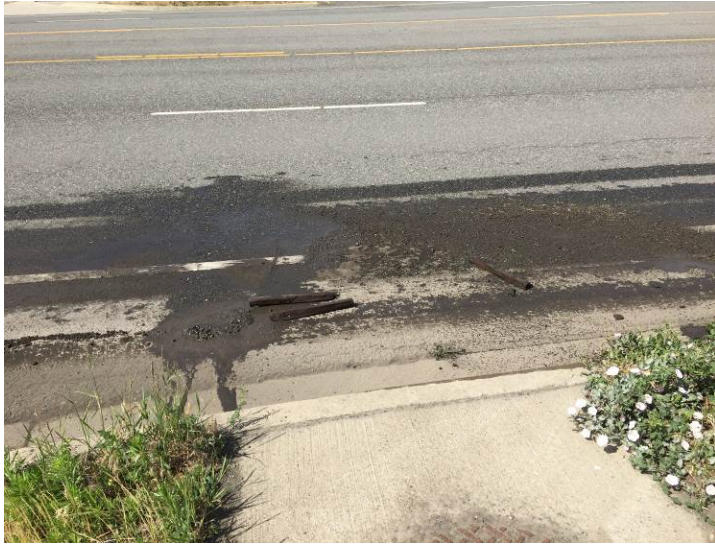
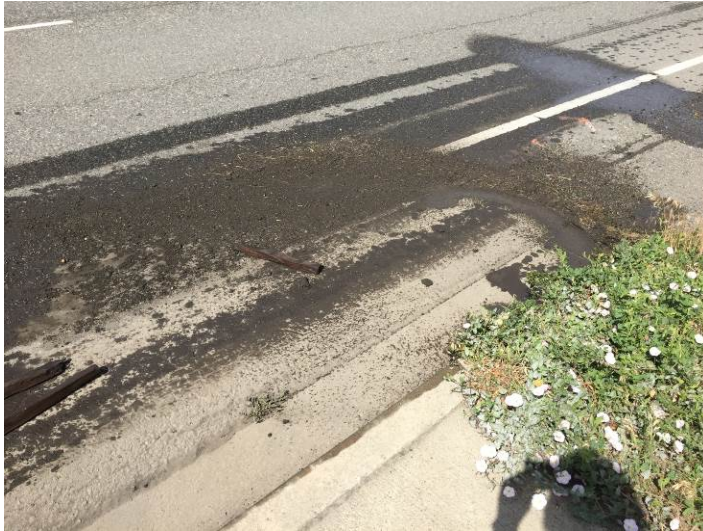
Material left behind after sweeper completed sweeping at site (just beyond crown/end of contributing basin) and lifted vacuum head below truck to drive away

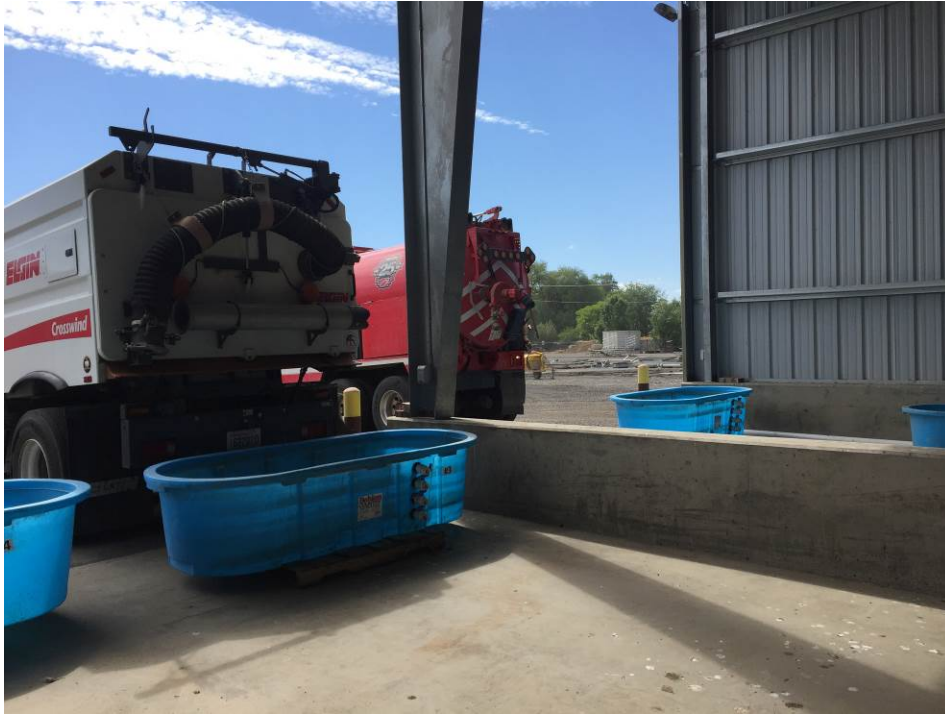
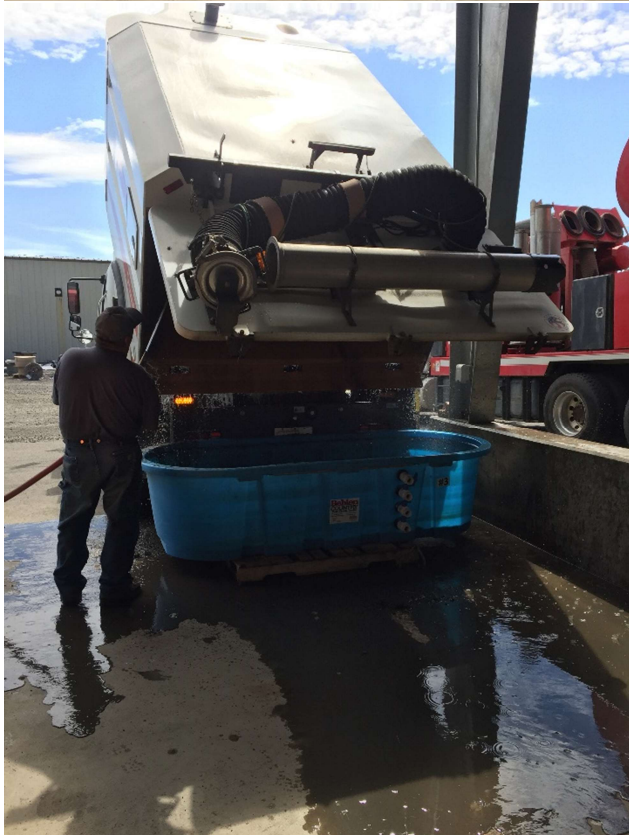
First photo shows the decant facility and basins with sweeper truck on the left and vactor truck on the right. Second photo shows the sweeper operator spraying out the inside of the debris tank to remove any remaining sediment inside the tank.

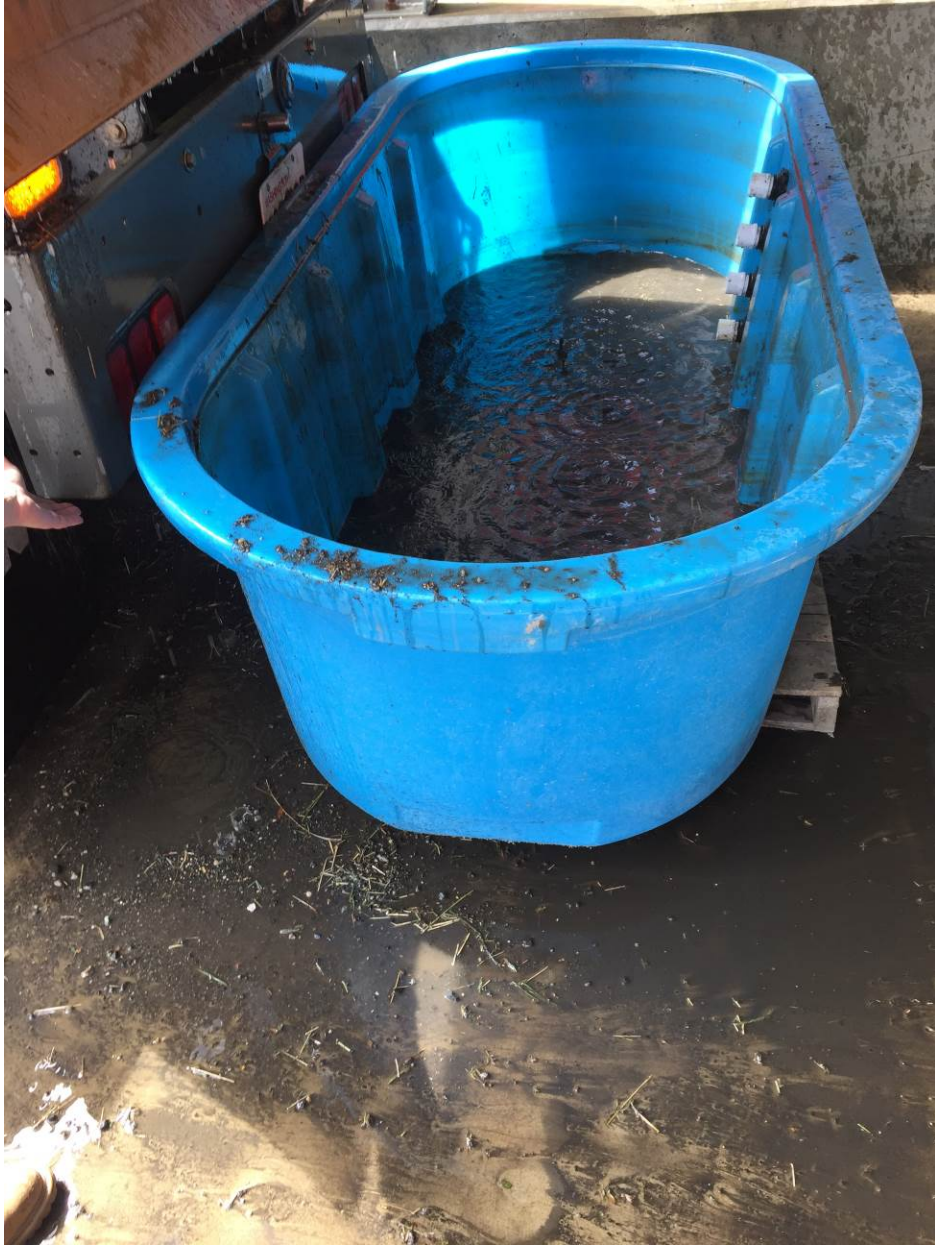
Photo shows street sweeping solids plus water used to wash out debris tank. Sediment on the decant facility floor (from emptying the sweeper debris tank) is typically allowed to dry and is scooped/shoveled into the basin with the rest of the sediment to minimize losses. Was told this amount is about 1/3 of what was collected from sweeping in April.

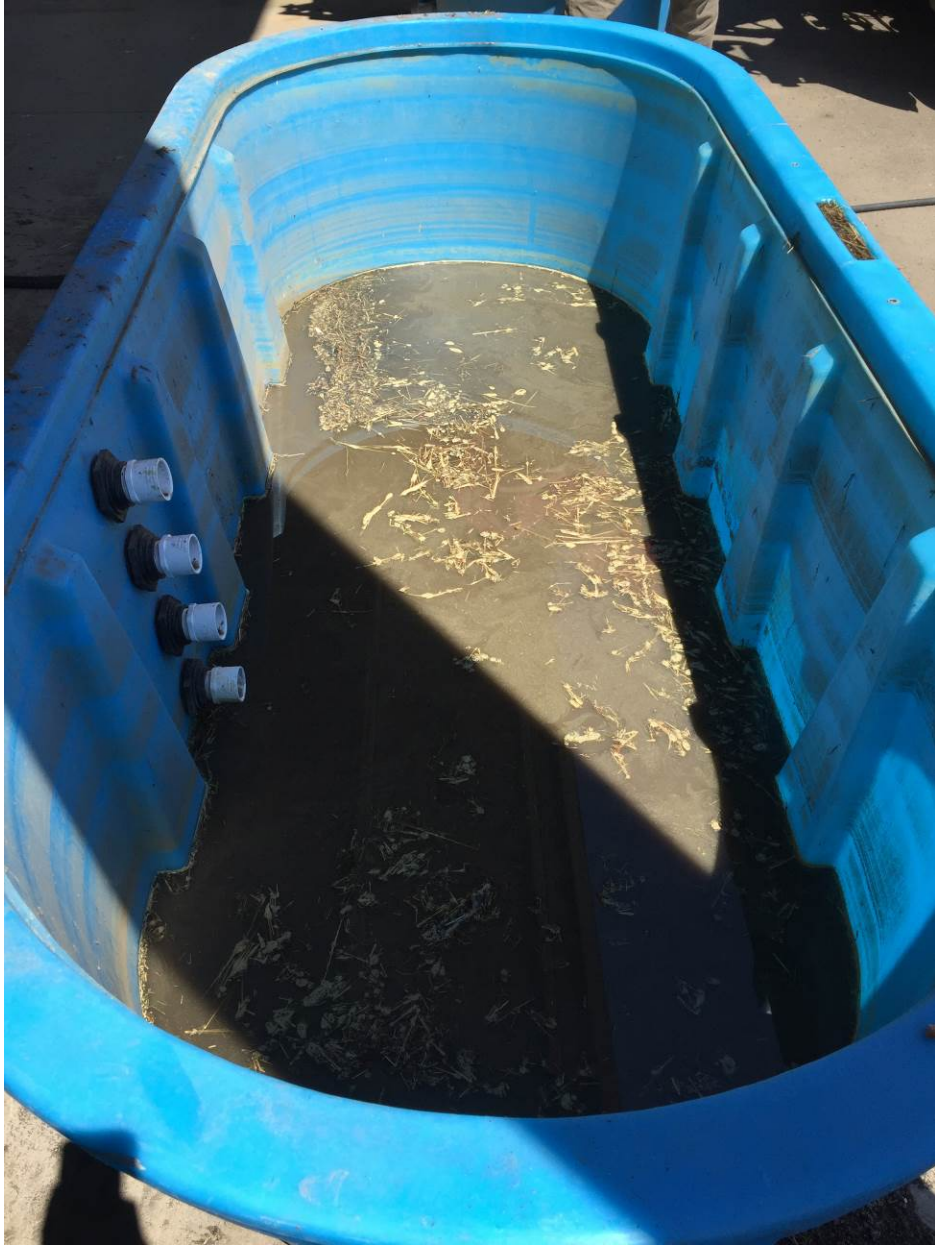
Another picture showing what was collected during the street sweeping. Slight sheen (possibly biological from breakdown of hay?) and hay chaff was observed.

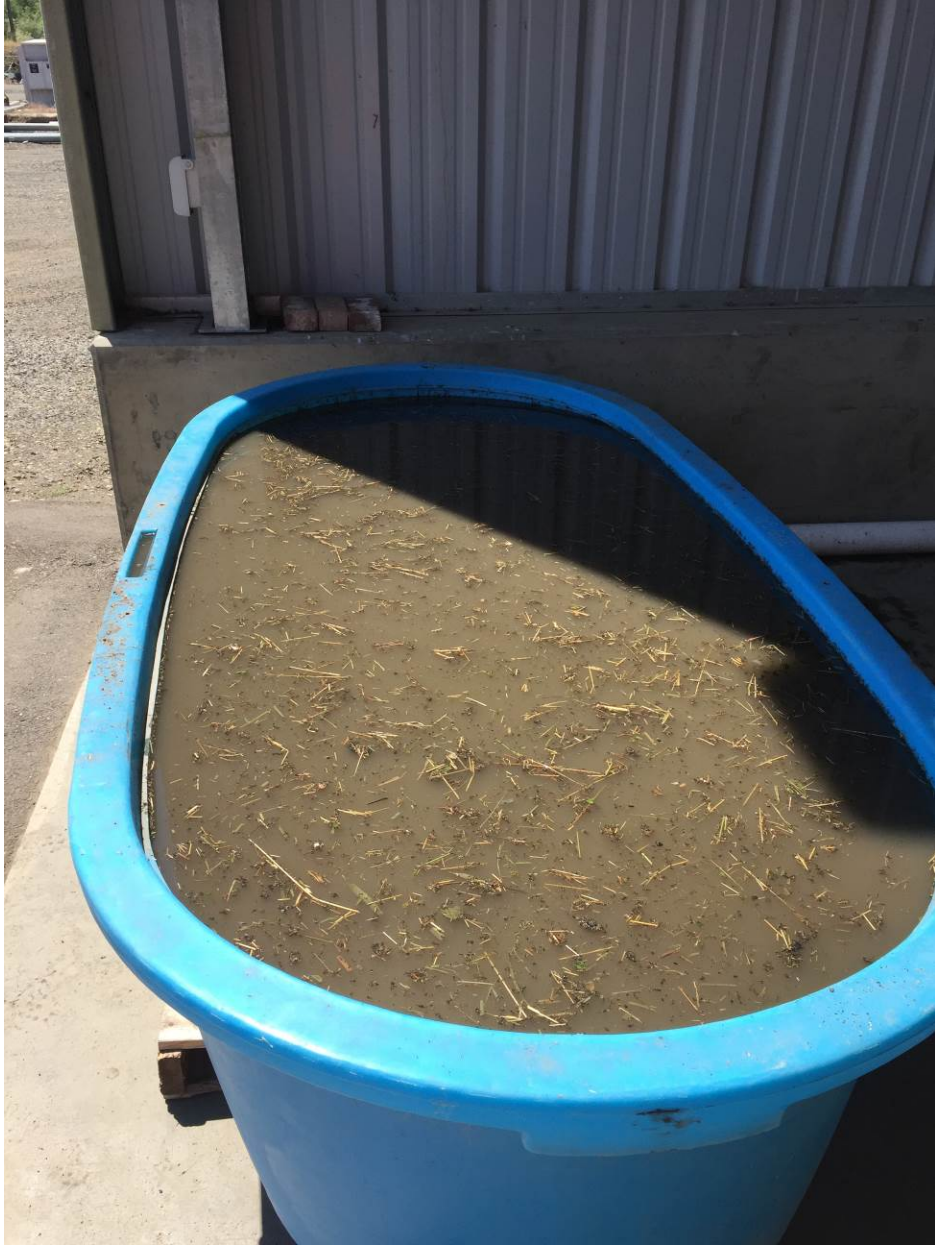
Material collected during catch basin cleaning. Appeared to fill the basin to almost the same depth as in April. Smelled horrible. No dead mice observed.
