NON-VEGETATED FILTRATION SWALE EFFECTIVENESS STUDY

Study Goal and Background

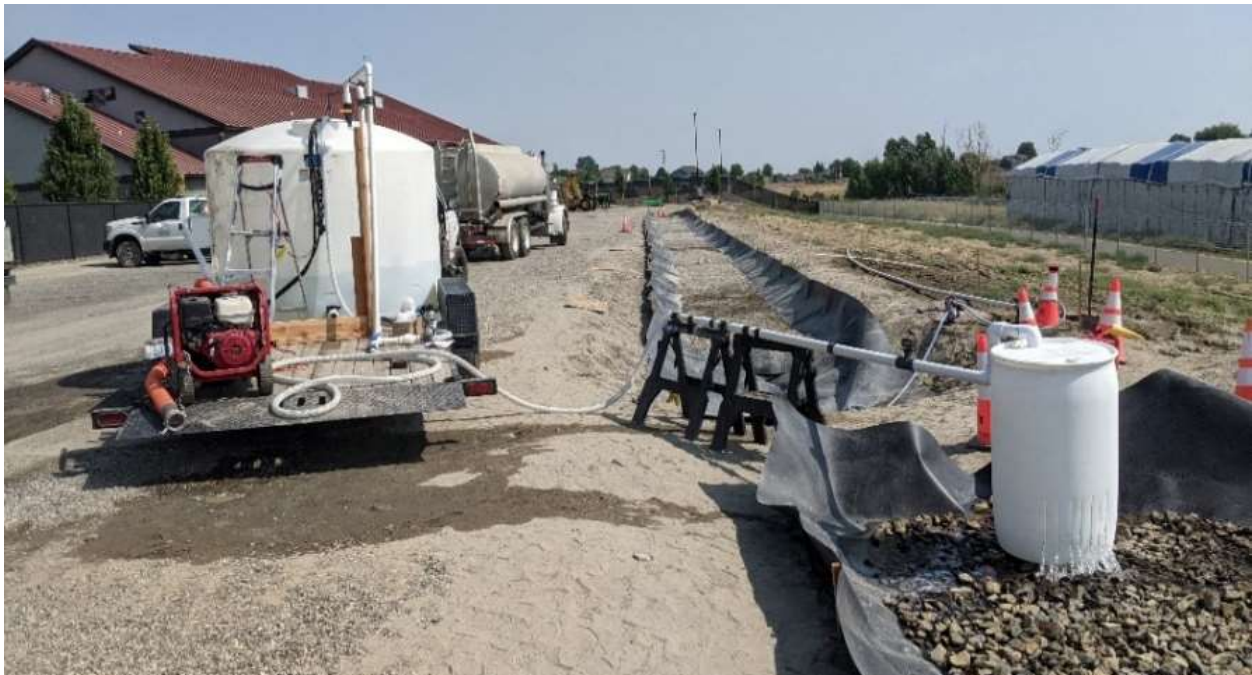
FIGURE 3: INFLUENT DISTRIBUTION SYSTEM AT TEST SWALE

Treatment performance was measured from samples collected from each alternative, which were analyzed for total suspended solids (TSS). An influent distribution system mixed and pumped synthetic stormwater to the swale at the design flow rate to simulate a storm event (as shown in **Figure 3**).

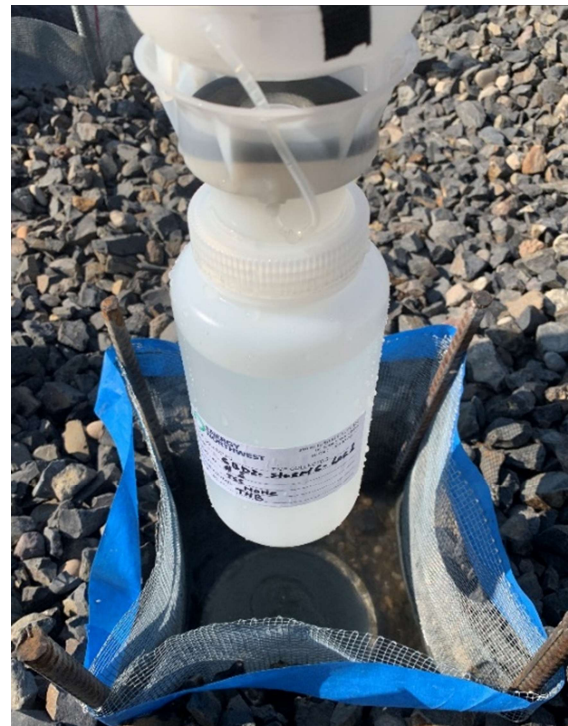
Figure 4: GRAB SAMPLE FROM TEST SWALE

As the synthetic stormwater flowed through the swale, grab samples (shown in **Figure 4**) were collected in eight sample locations that were spaced at 25-foot increments along the swale. After each simulated storm event, an amount of TSS equivalent to one year of loading was distributed to the swale to stress-test the swale and determine when the swale would require maintenance.

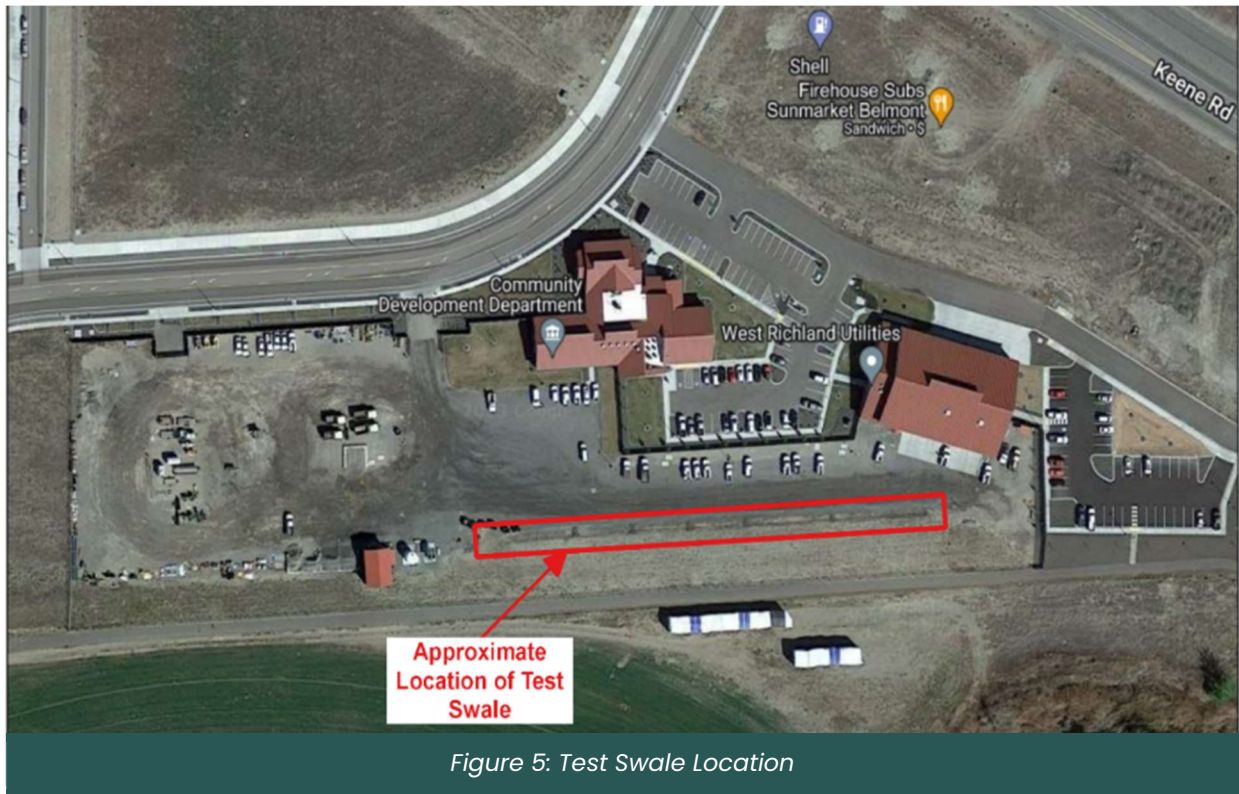
The test site location was south of the City of West Richland Public Works Building and adjacent to a gravel parking lot (as seen in **Figure 5**). An existing 430-foot-long swale at the test site was retrofitted into the two 200-foot-long test swales. The controlled tests were conducted during the dry season; therefore, no runoff from the gravel parking lot contributed to the test swales.
